<b>Item No.</b>	<b>Classification:</b> Open	<b>Date:</b> 29 October 2019	<b>Meeting Name:</b> Cabinet
<b>Report title:</b>		Ledbury Towers Arup Structural Survey Report	
<b>Ward(s) or groups affected:</b>		Old Kent Road	
<b>Cabinet Member:</b>		Councillor Kieron Williams, Housing Management and Modernisation

Before proceeding with this refurbishment the council engaged the structural engineers Arup to carry out intrusive investigations into the structure of Bromyard House to confirm the work needed to give the towers a further 50 plus years of life.

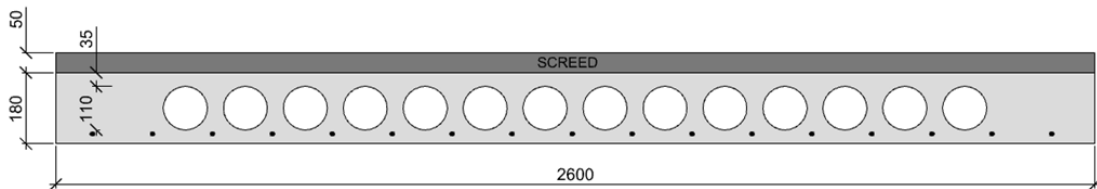
Typical floors investigated were found to be 180 mm deep hollow core planks with a 40-50 mm screed. The hollows in typical floor panels were 110 mm diameter and had a spacing of approximately 150 mm. The panels had bottom reinforcement of 10 mm bars at 150 mm centres as shown below:

The voids in the kitchen panel were irregularly spaced and did not seem to follow any pattern.

In general, the concrete covering the bottom reinforcement was found to be quite variable ranging from 10 to 32 mm.

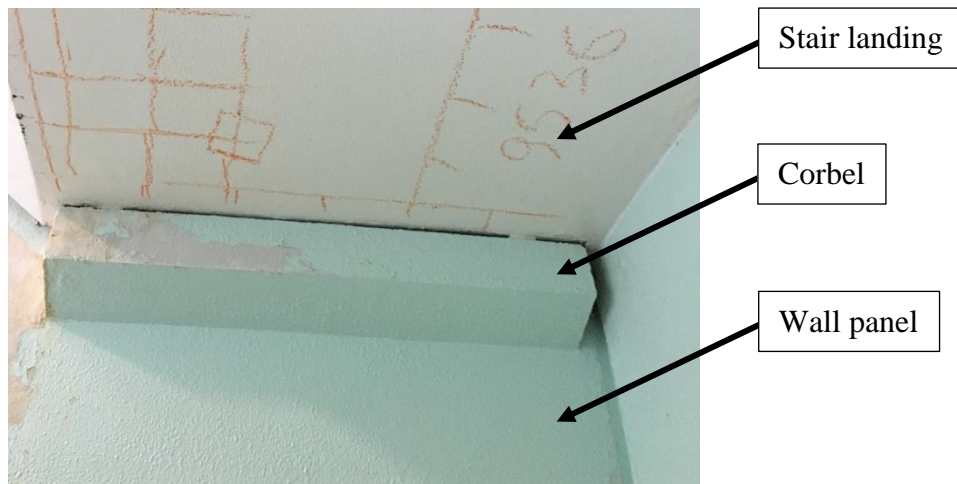
### Stair to wall connection

The stairs are supported at each landing by spanning onto ledges in the wall panels known as corbels. These are shown in the photo below. There is a horizontal gap between the stairs and the wall panels along the side of the stairs. It is therefore assumed that the stairs do not provide any lateral restraint to the wall panels.

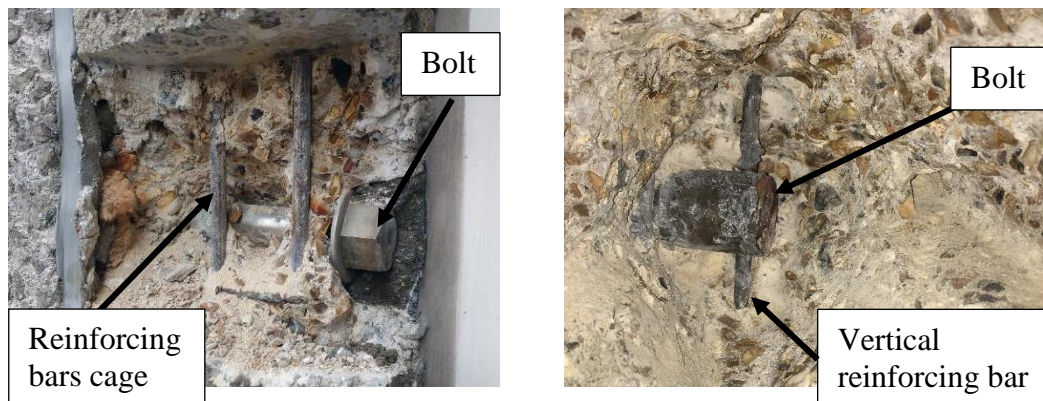
### Outer wall/ outer wall corner connection

The outer wall panels are connected at the corners by stainless steel bolts. The diameter of the bolts was confirmed as 34 mm. The anchorage of the bolts in the connecting wall has been confirmed through intrusive investigation in three locations. The anchorage length was found to be 120 mm and a vertical reinforcing bar was found to be welded to the bar as show in the photograph below. There are four bolts up the height of each panel.

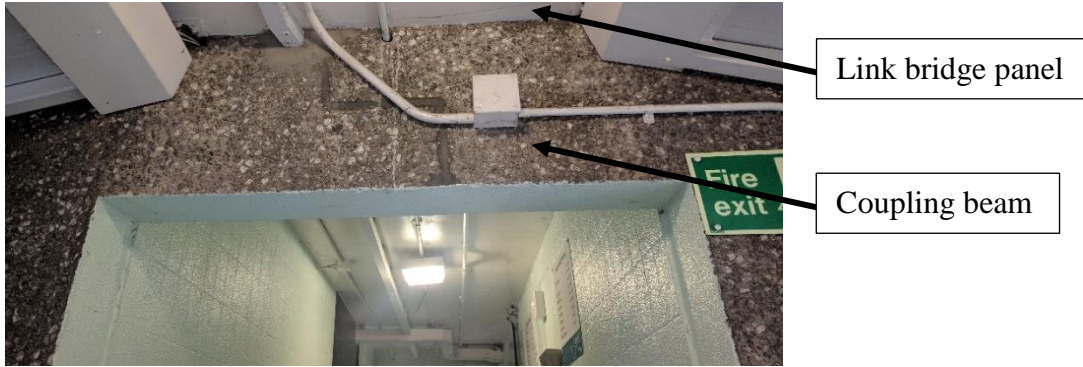
### **Coupling beam connection**

The outer walls on each side of the stair core are connected over the opening for the link bridges by the coupling beam shown in the photograph below. Ferro scans of the beams showed that they were reinforced but they did not confirm the connecting detail. These connections were not investigated intrusively as it could not be done safely as it provides the gravity load path for the floor slab.

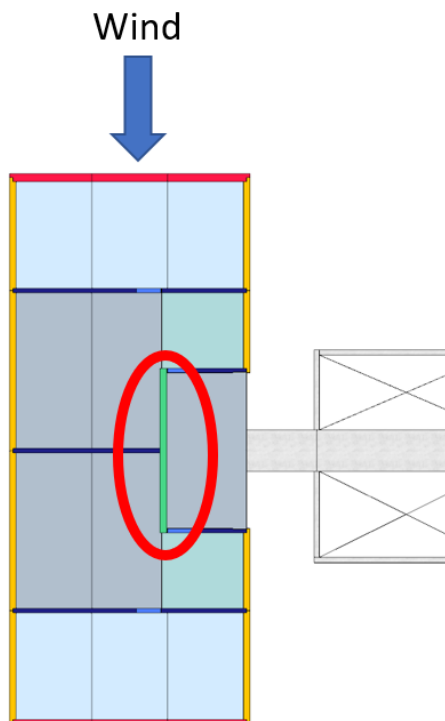
The residential blocks have only one shear wall to resist wind on the narrow face:

Since this wall is very lightly reinforced (as shown in Section 2.1.2) it is susceptible to “second order” effects. Calculations show that this shear wall is just strong enough to resist modern wind loads.

Whilst the superstructure is adequate for modern wind loading, the anchorage of the shear walls into the raft foundation was uncertain since very little information about the foundation is known. As a result, it has not been possible to confirm the foundation's ability to resist the wind "overturning" forces at the base of the shear wall.

Since the anchorage of the shear wall reinforcement into the foundation is unknown (and likely to be deficient since the wind loads the building was designed for are known to have been too low) and the workmanship of the connections in the shear wall at every joint at floor level is unknown (but known to be vulnerable to poor site workmanship; sand was found in one of the wall to wall connections), it is proposed to include enough steel reinforcement for modern wind loading within the new jacketing.

In addition, since it has not been possible to gain sufficient confidence in the capacity of the existing raft foundation or the anchorage of the main shear wall reinforcement into the raft (and again since these are likely to be deficient since the wind loads the building was designed for are known to have been too low), it is proposed to cast a new raft foundation over the existing raft.

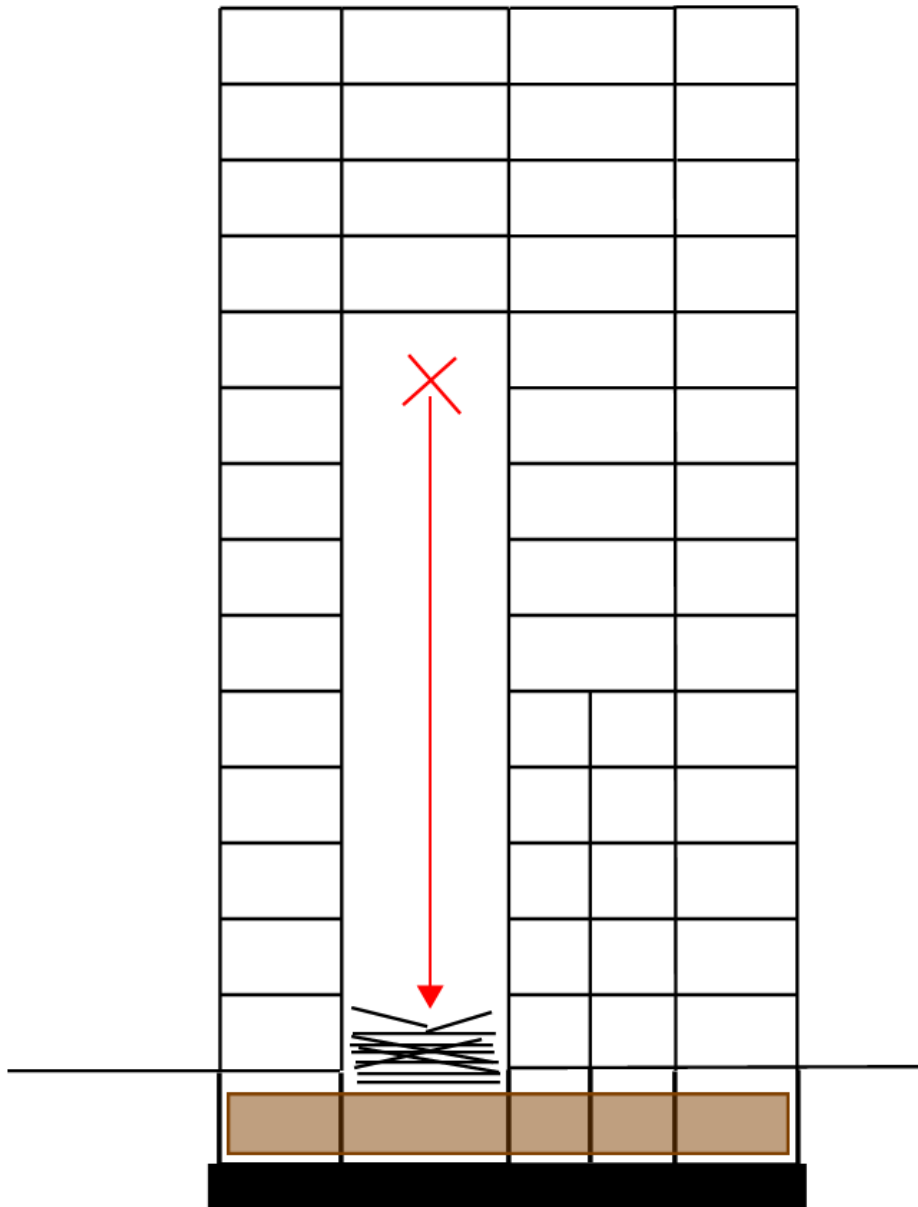
The floors in Ledbury not only support themselves and their loads but also provide buckling restraint to the flank walls, cross walls and to the main shear wall. A possible accidental event such as the explosion of a gas canister would cause one or more floor panels to fail. Failure of a single floor could cause ‘pancaking’ whereby the failed panel falls onto the floor below, putting additional weight onto that floor leading to disproportionate collapse as seen at Ronan Point.

Further the loss of floors could also lead to the disproportionate collapse of the structural walls as the loss of horizontal restraint would mean that the walls would buckle. Hence the floors cannot be allowed to fail.

Therefore, it is proposed to strengthen the floors to withstand 17 kPa. Strengthening the floors also usefully means that they would be able to provide lateral restraint to the flank walls in the event of an internal pressure of 17 kPa being applied to the flank walls.
