# Stock Condition Survey Report

Tustin Estate, London Borough of Southwark

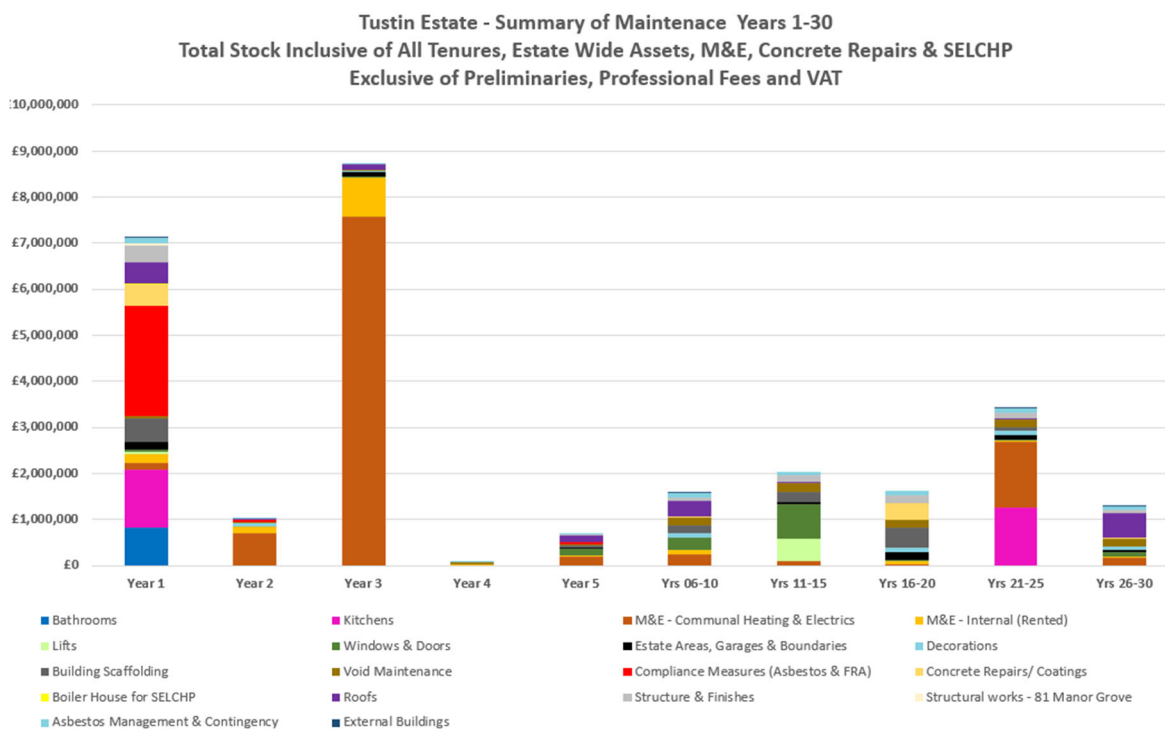
11.12 It should be recognised however that the timing of repairs is purely as recorded by surveyors in the field. In reality, costs would be smoothed and organised into logical programmes of works to achieve economies of scale and fit within budgetary constraints. This work lies outside the scope of this report, but the information given provides a starting point for discussion on this aspect and the preparation of outline programmes of work. The chart costs are nett of preliminaries, professional fees and VAT.

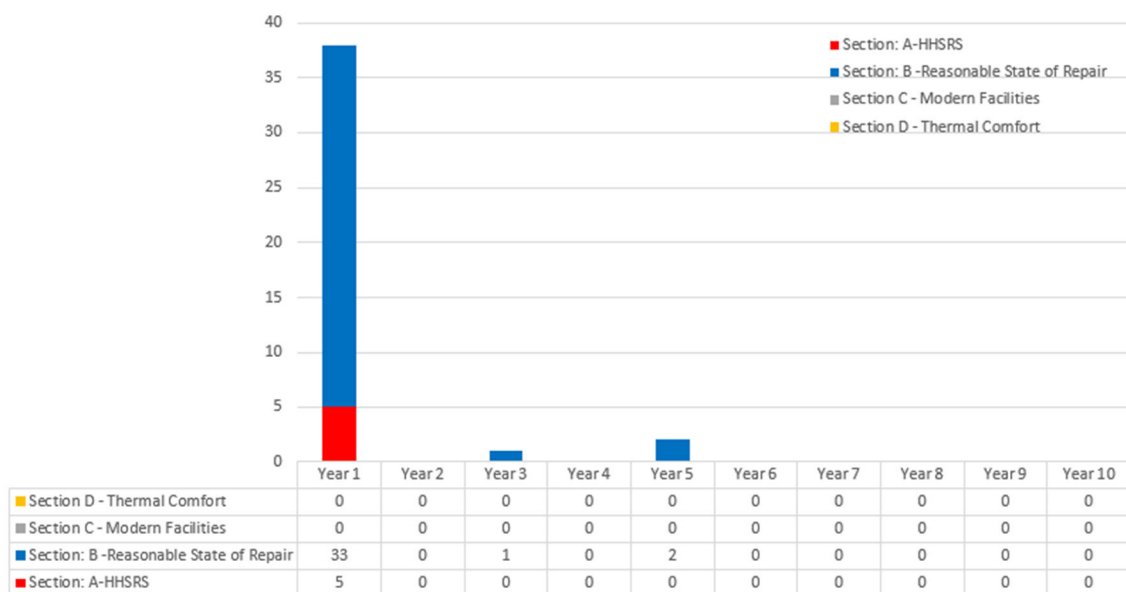
11.15 The costs attributable to work to maintain the Decent Homes Standard are shown in the bar chart below. As is the case of the major repairs cashflow, these costs are exclusive of contractors' preliminaries, professional fees, and VAT. The total cost of maintenance over the first five years is estimated to be £16.9 million, and costs for the next five years (6-10) are estimated to be a further £1.2 million. Of this overall total, current non decency in year year1 is estimated at £109,016 representative of 38 properties.

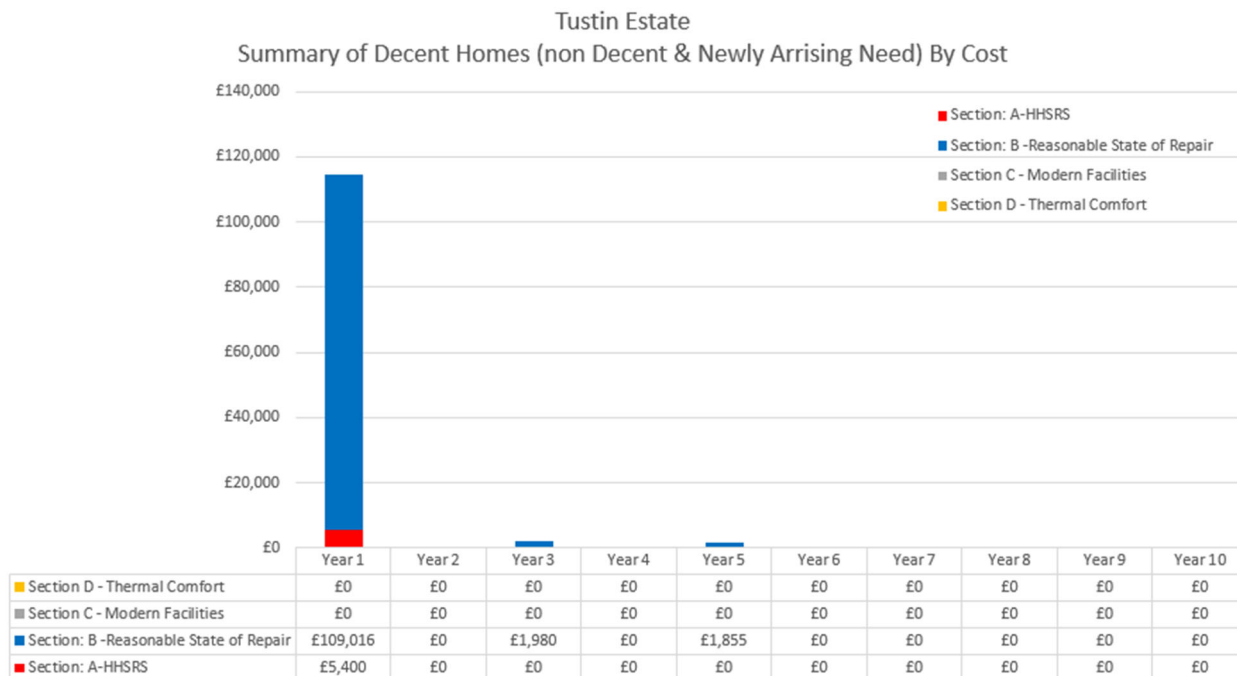
11.16 As with any costs produced within decent homes, these are heavily reliant upon an estimate of the date of installation of the component which is recorded by the surveyor. This is because the algorithm applied specifically to sections B and C, relates to the installation date of a component and further considers the year the work is anticipated for renewal. We would advise upon receipt of our database, that the dates of installation are refined for the key components of electrics, boilers, kitchens and bathrooms based upon records of installation and cyclical inspection.

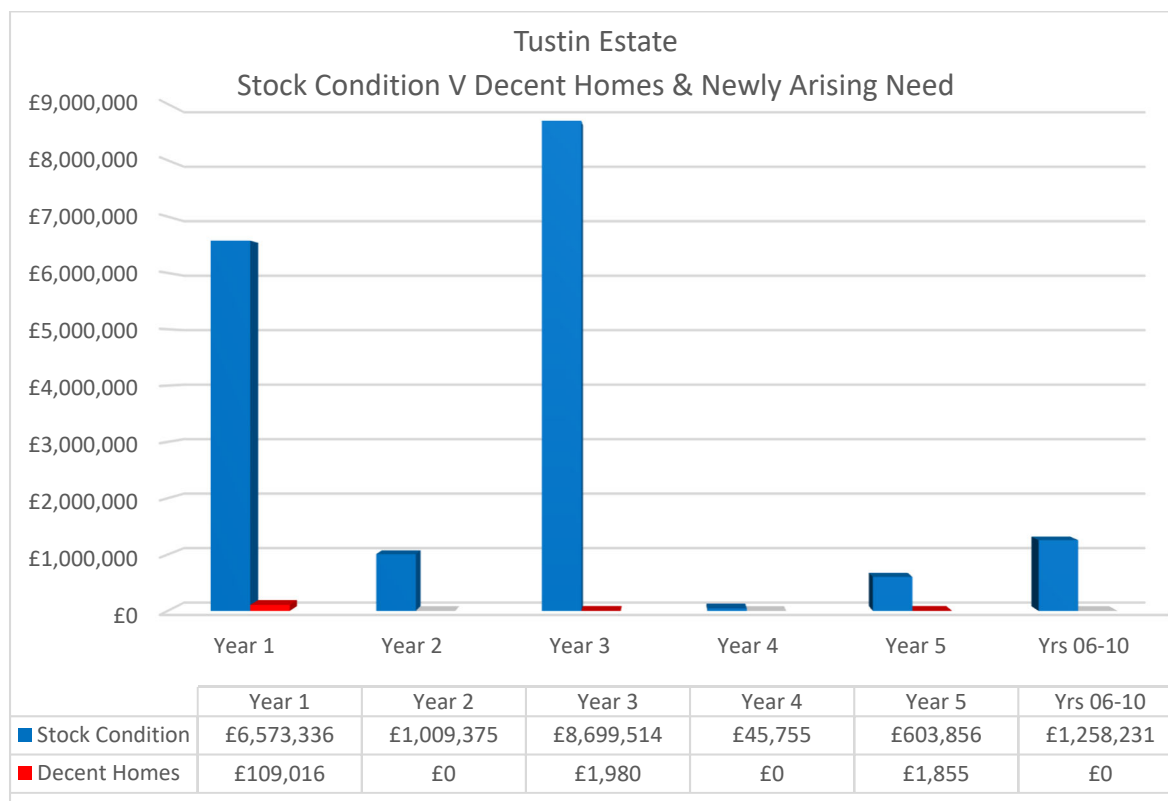
The chart below, shows the relationship between the stock condition survey and the proportion of cost relating to current non decency (Year 1) and newly arising need work (Years 2-10). It is important to note, the cost shown in this graph are there to show the costs to remedy decent homes versus the overall costs in the stock condition survey. The costs to remedy non decency are already accounted for within the stock condition survey (Blue bars) and are not an addition to them.

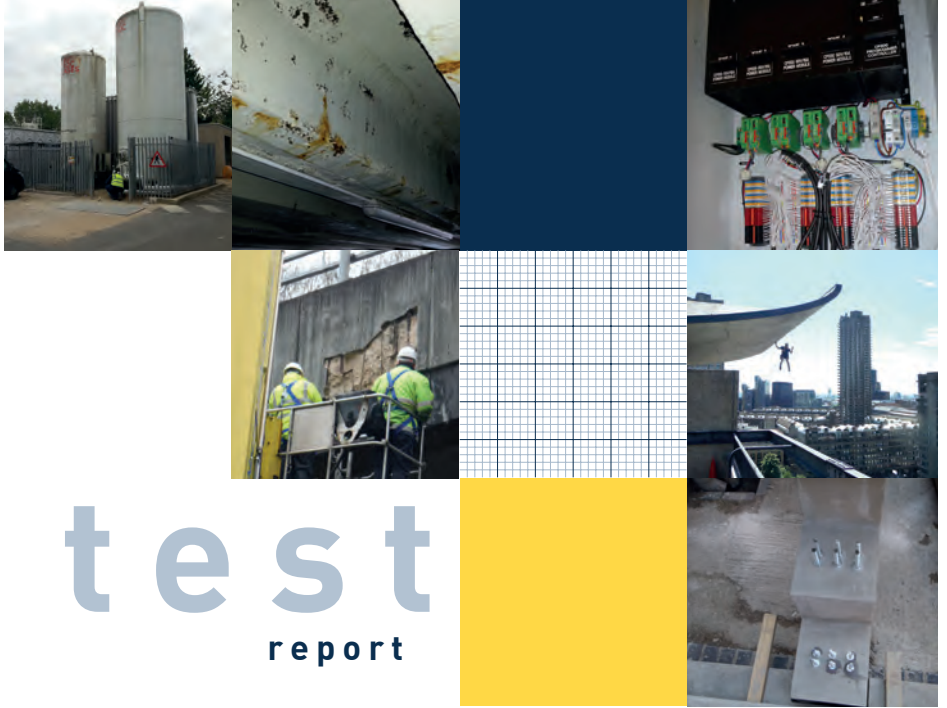
Concrete Repairs Report

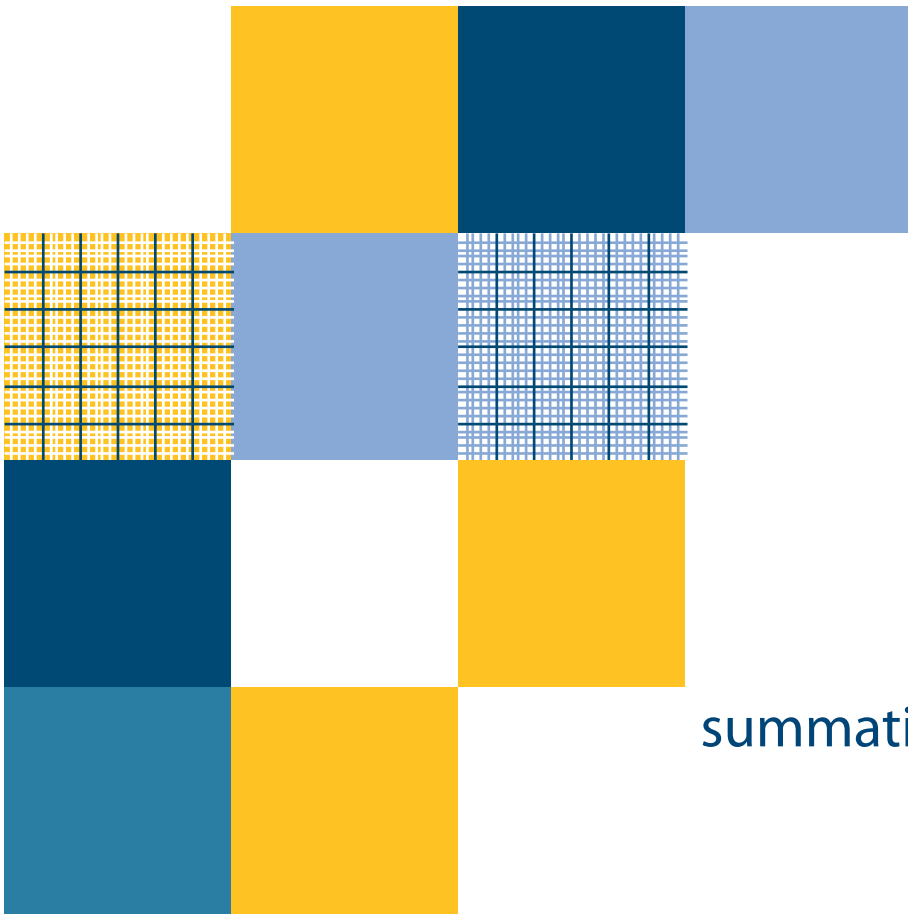
© Martech Technical Services Ltd (2020). This report is copyright. Reproduction of the whole or any part thereof must not be made without the express permission of Martech. This report, the results shown and any recommendations made herein are based upon the information, drawings, samples and tests referred to in the report. Martech accepts no liability, beyond three times the value of the original instruction, for any damages, charges, costs (including, but not limited to, legal costs) or expenses in respect of or in relation to any damage to any property or other loss (save for death or personal injury occasioned by reason of any negligence on the part of Martech) whatsoever arising either directly or indirectly from the use of the report, the carrying out of any recommendations contained therein, the following of advice or the use of any goods or materials referred to in this report.

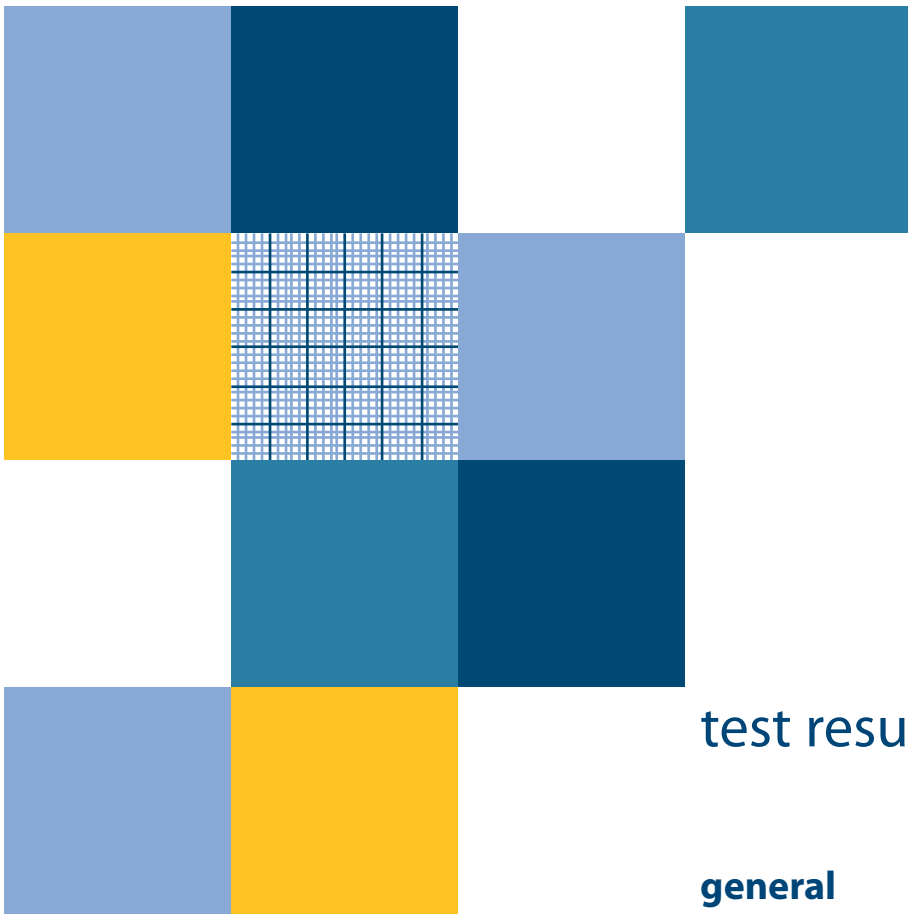
Our Engineers carried out the site work in the weeks commencing 2<sup>nd</sup> and 9<sup>th</sup> December 2019 and their findings are the subject of this interpretative report.

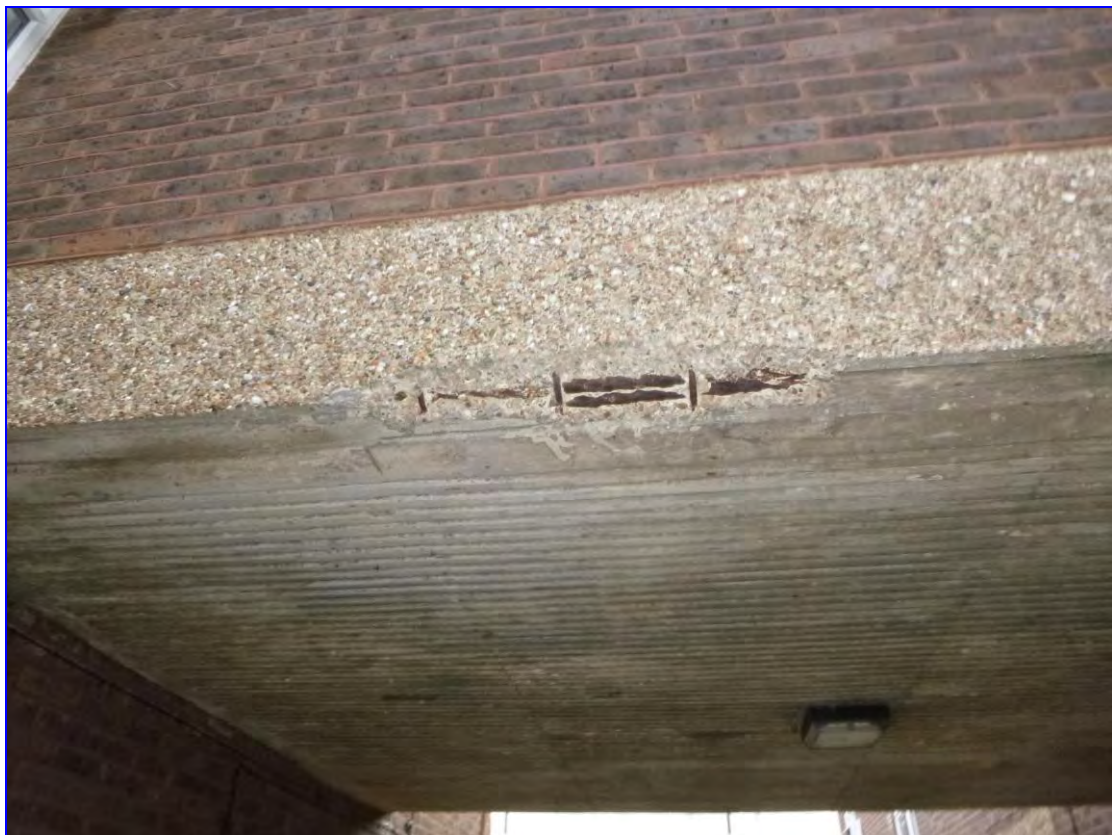
Photograph 7: Example of spalling and visible reinforcement on Manor Grove, to a link section.

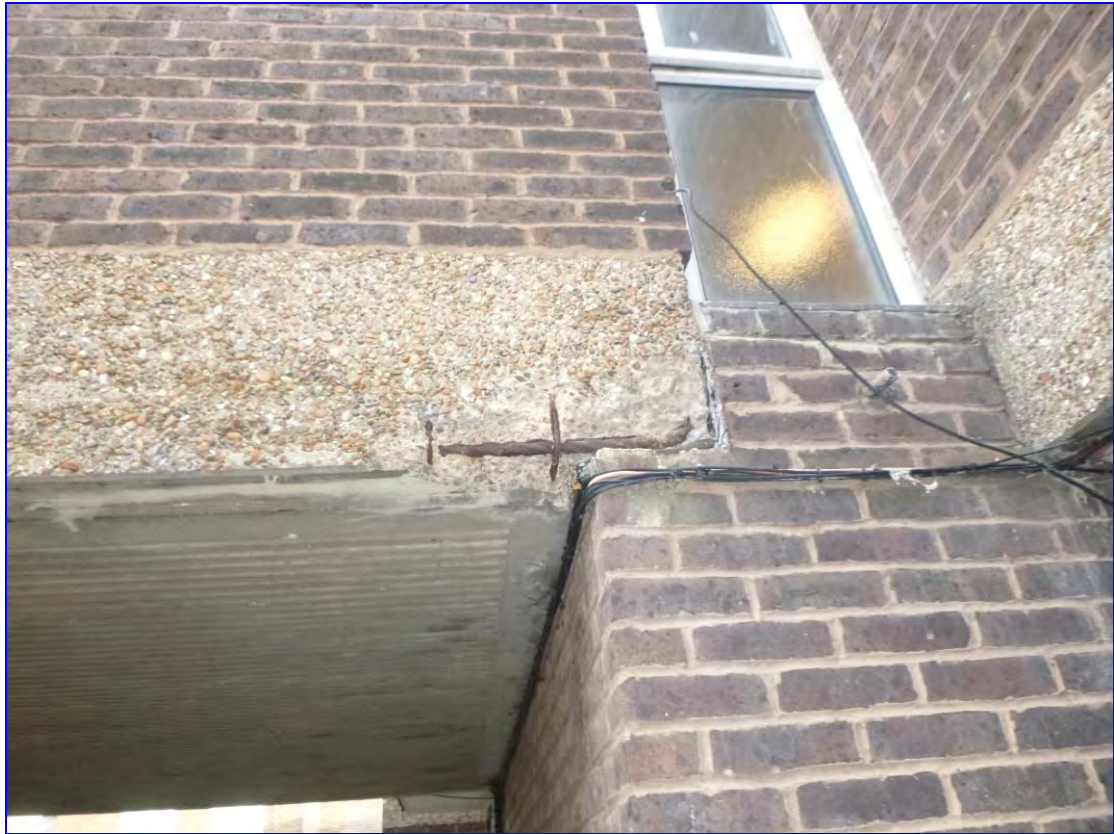
Photograph 8: Another example of a spall to Manor Grove.

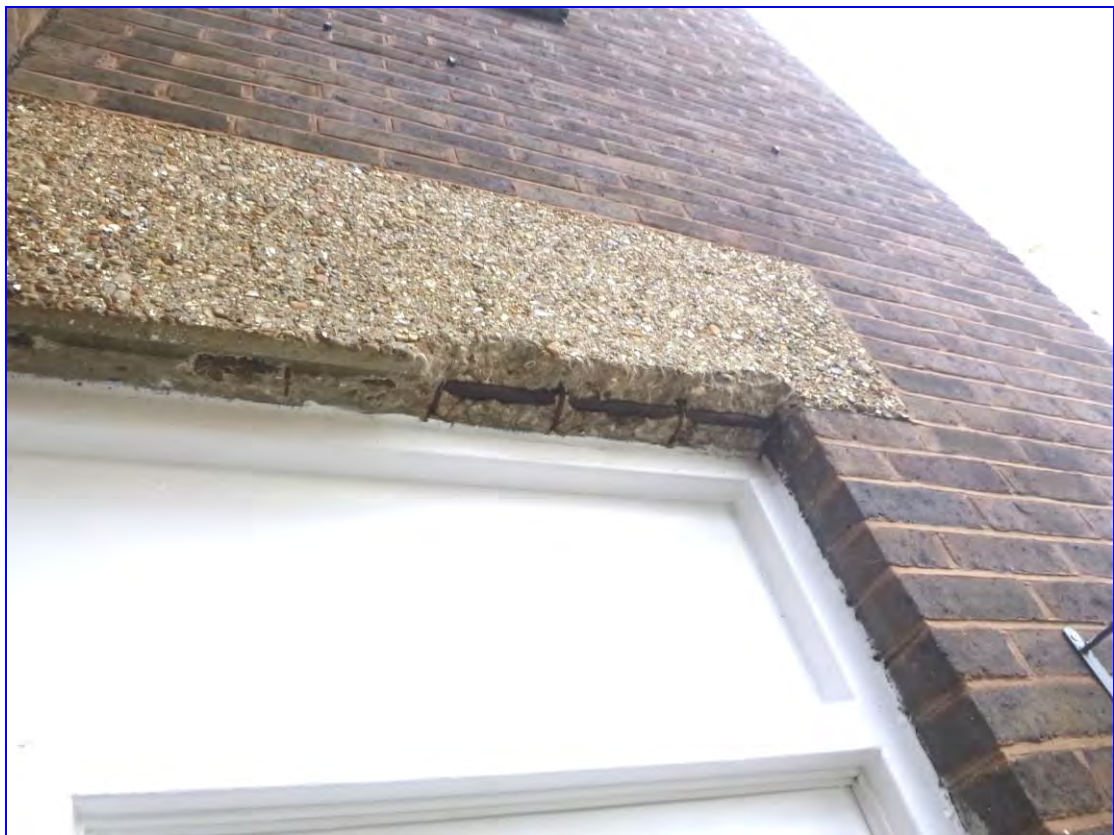
Photograph 9: Another example of spalling and low cover at drip detail, Manor Grove.

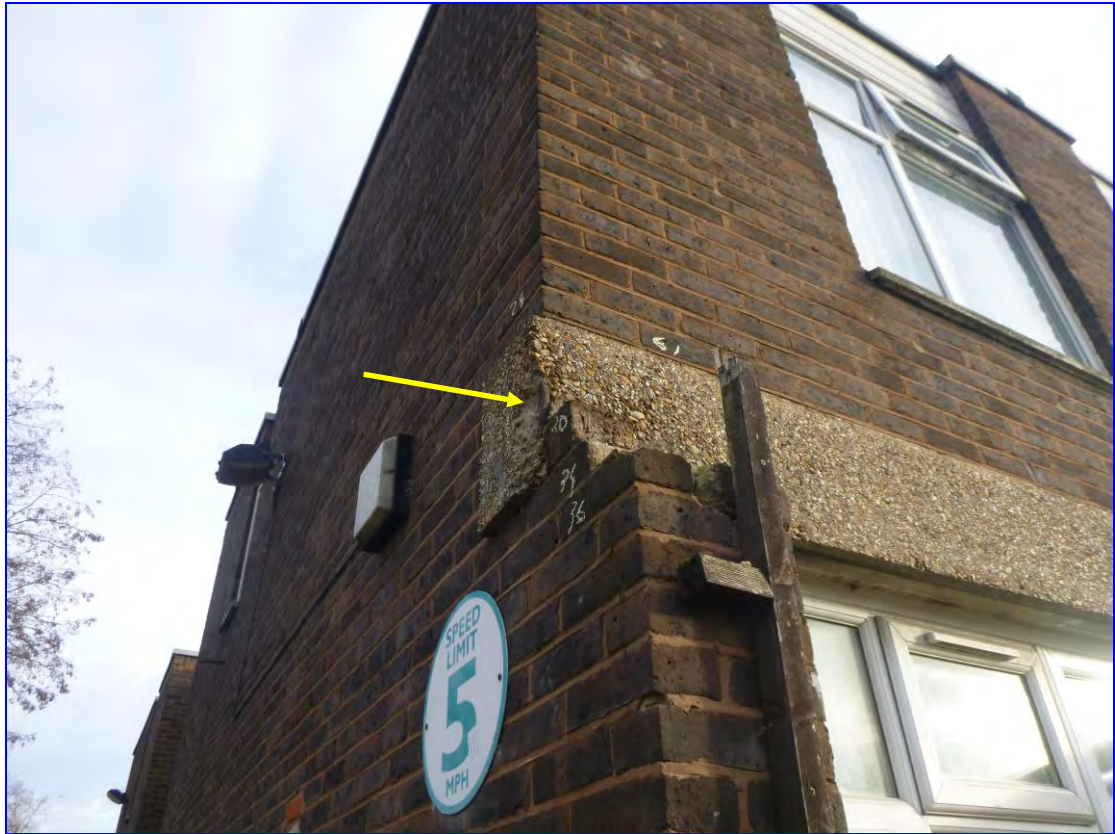
Photograph 10: Spalling to a corner, Manor Grove.

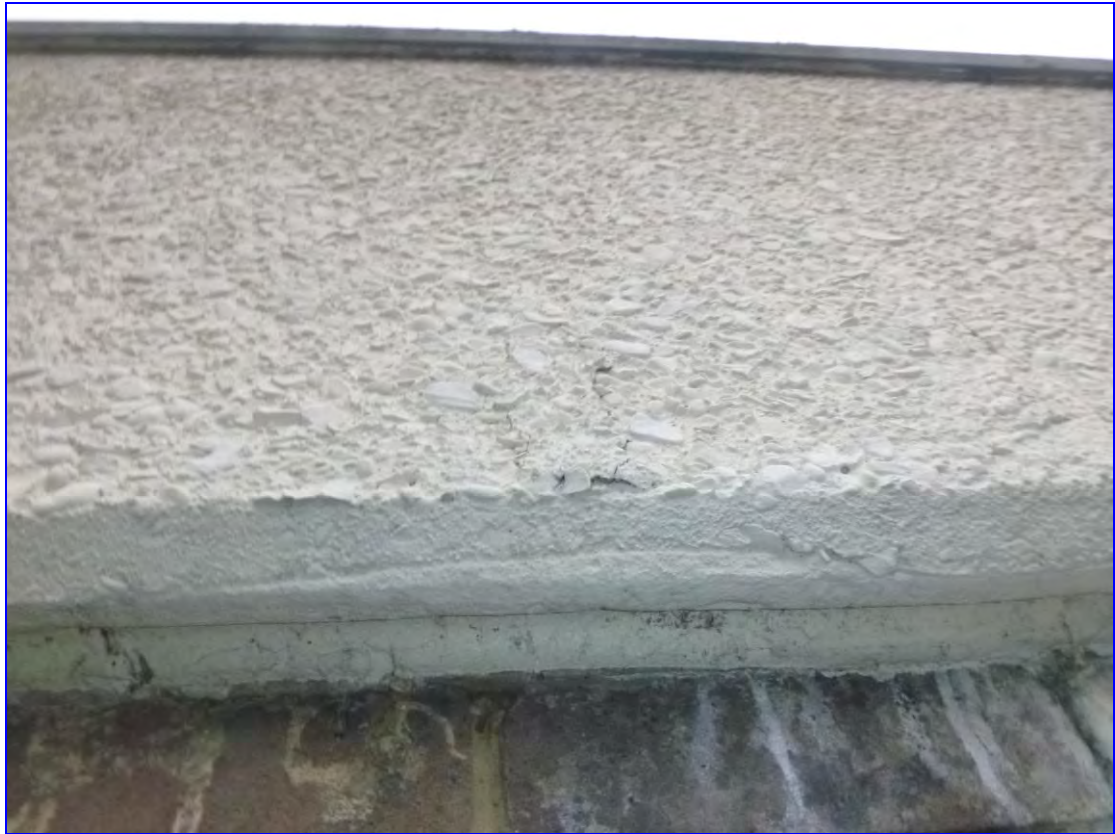
Photograph 11: Spalling to roof beam on Kentmere House.

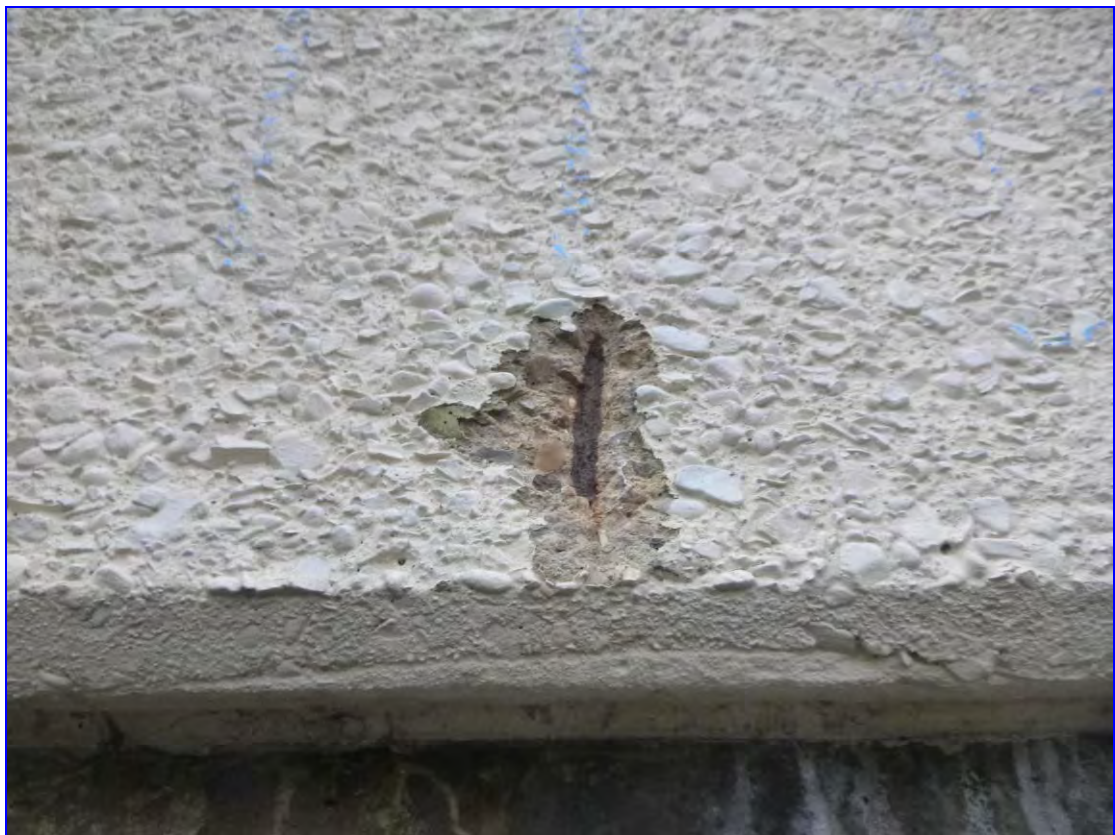
Photograph 12: As photo 11, after spalling material removed revealing corroded rebar.

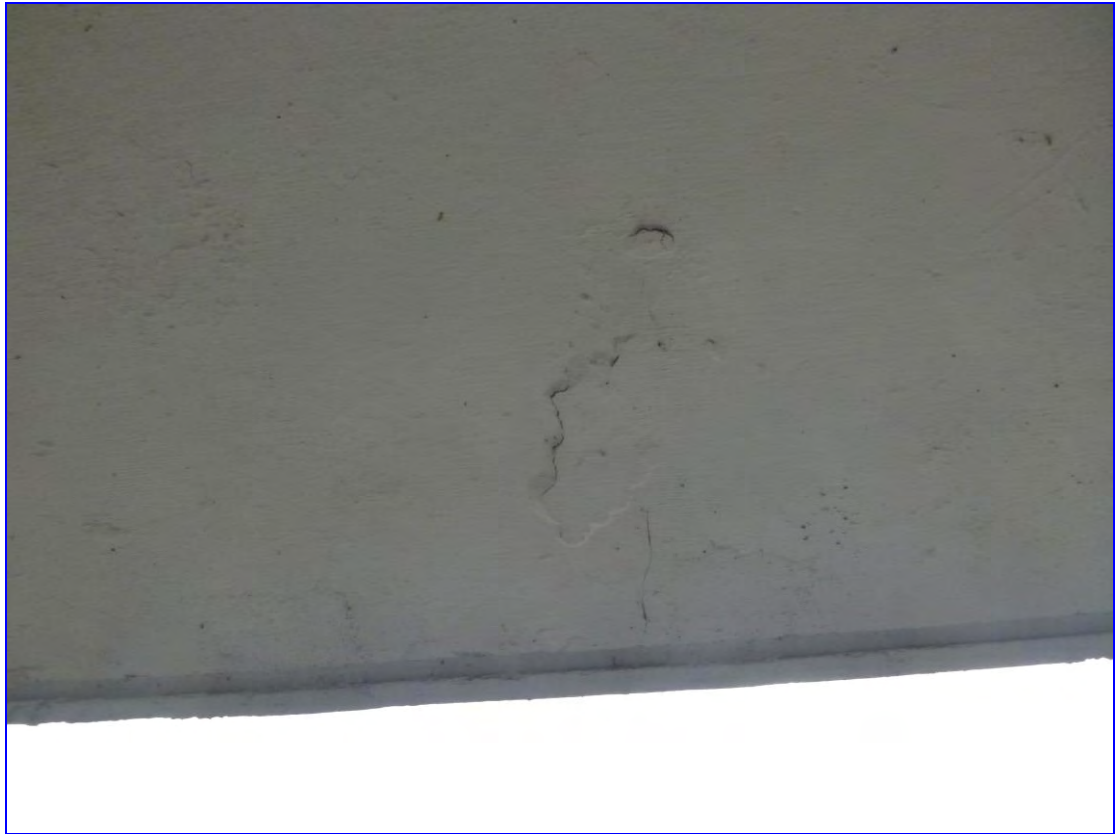
Photograph 13: Spalling to soffit, Kentmere House, at TA52.

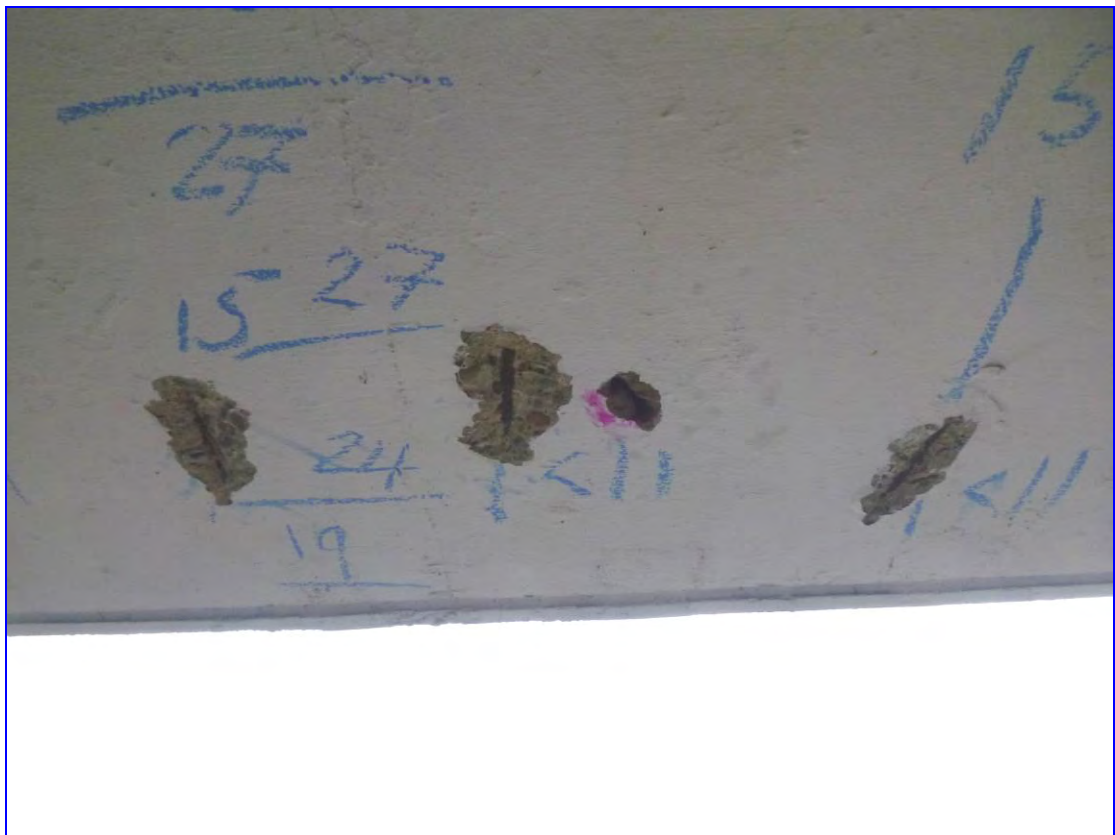
Photograph 14: As photo 13 after spalling material removed at the test area.

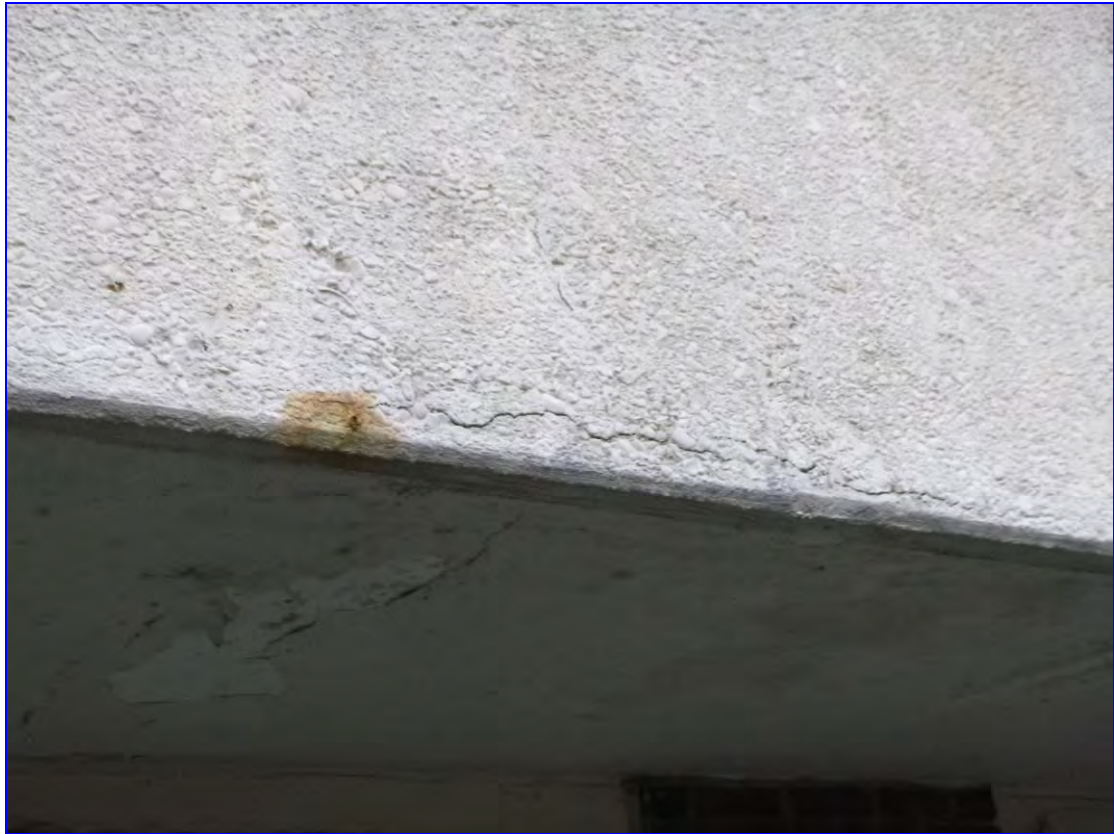
Photograph 15: Another example of spalling on Kentmere House. Also note deteriorated paint coatings to soffit.

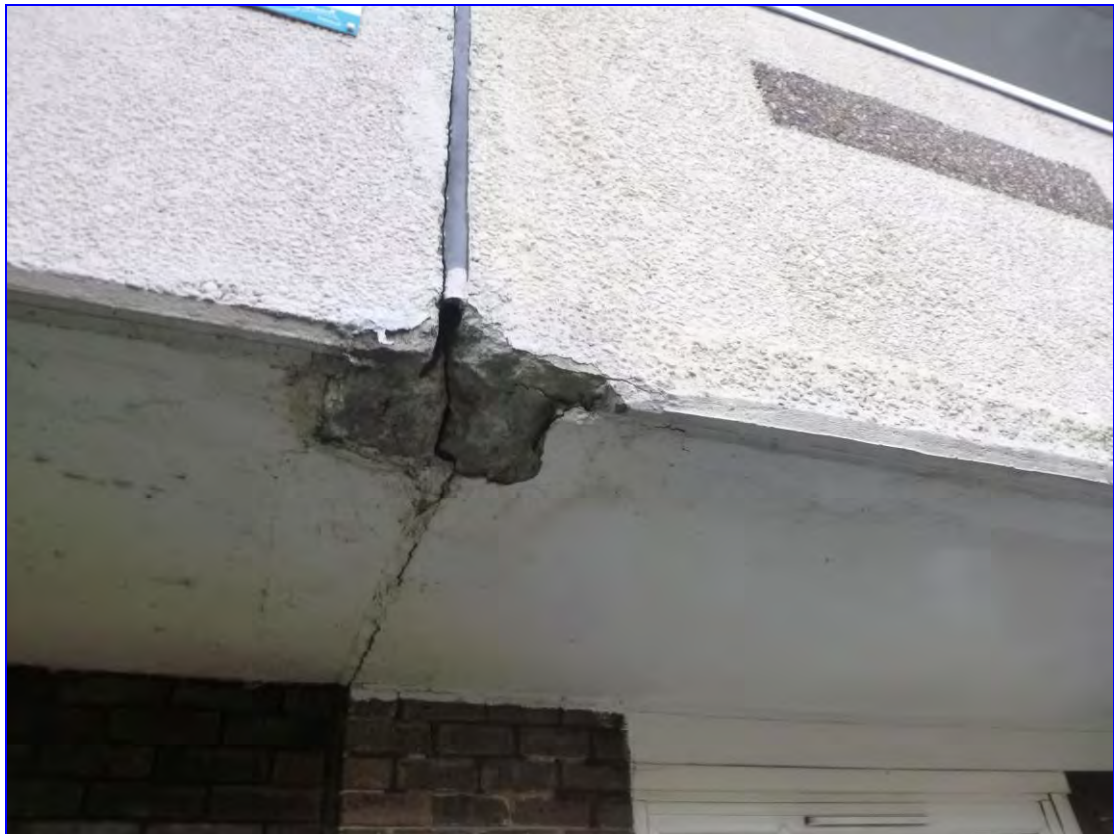
Photograph 16: Further example of deterioration on Kentmere House.

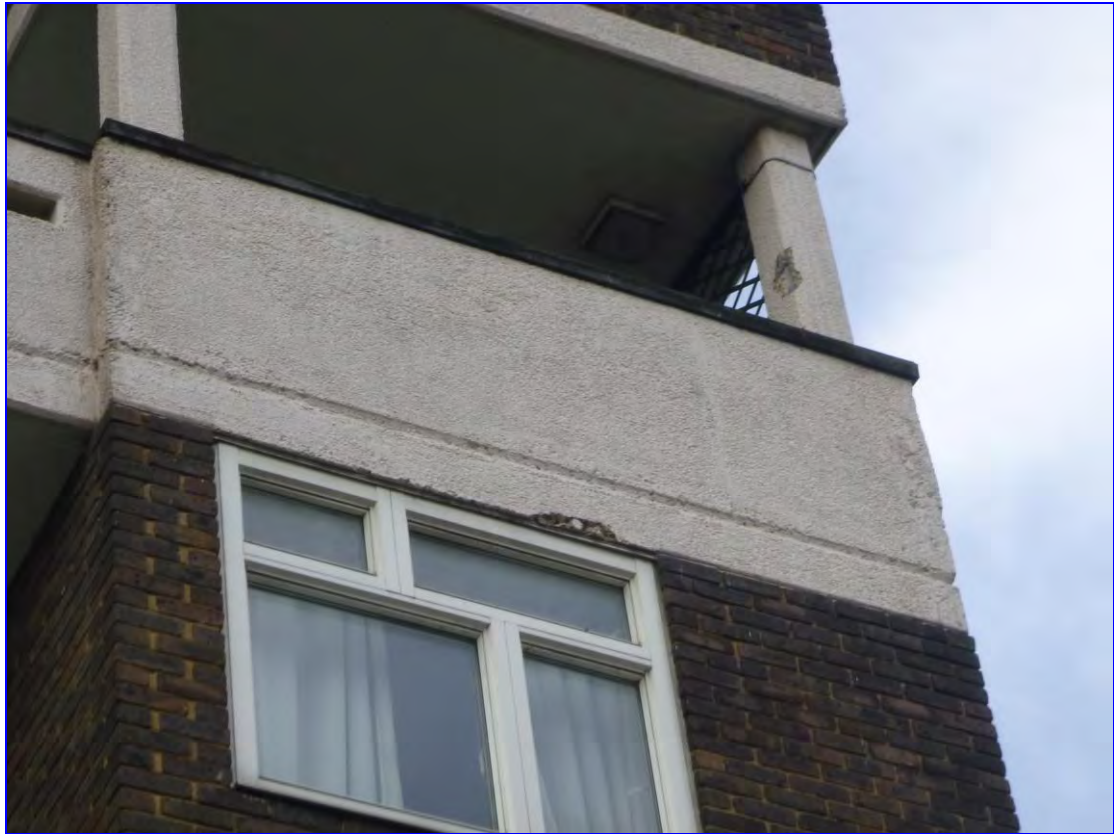
Photograph 17: Example of spalls to Heversham House, here to window head and column above.

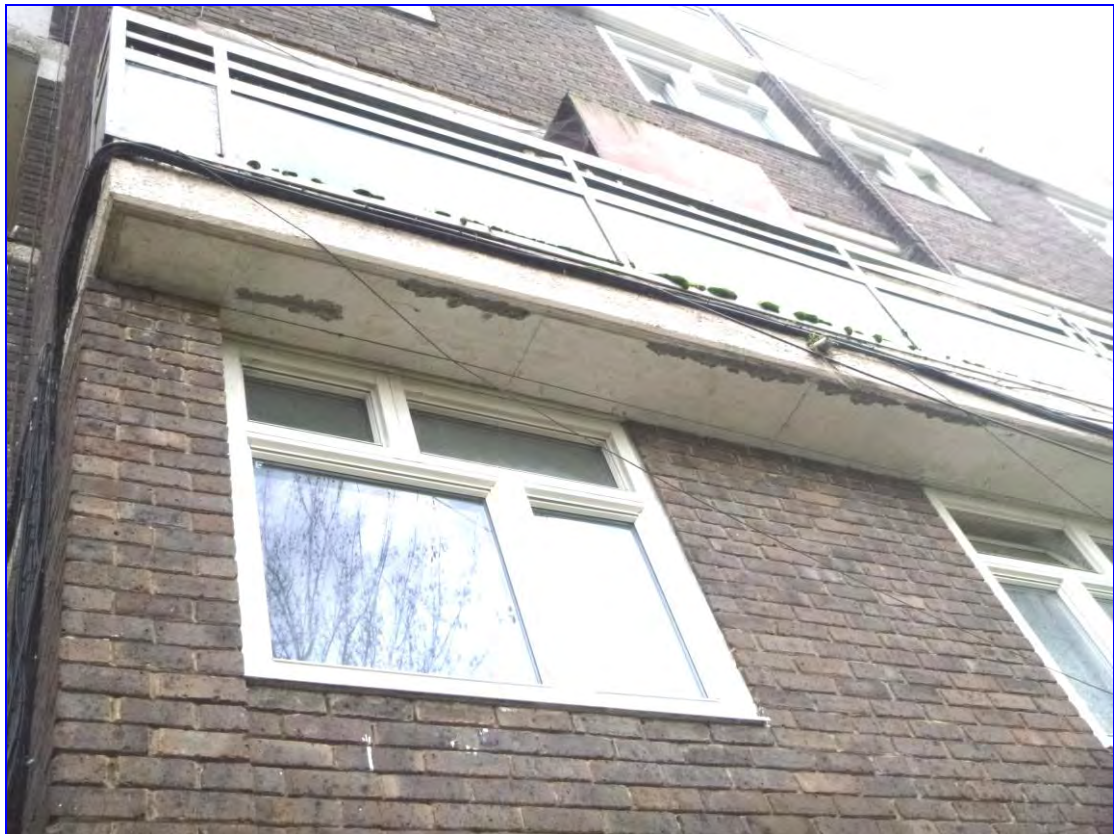
Photograph 18: Spalls noted to slab soffit on Heversham House.

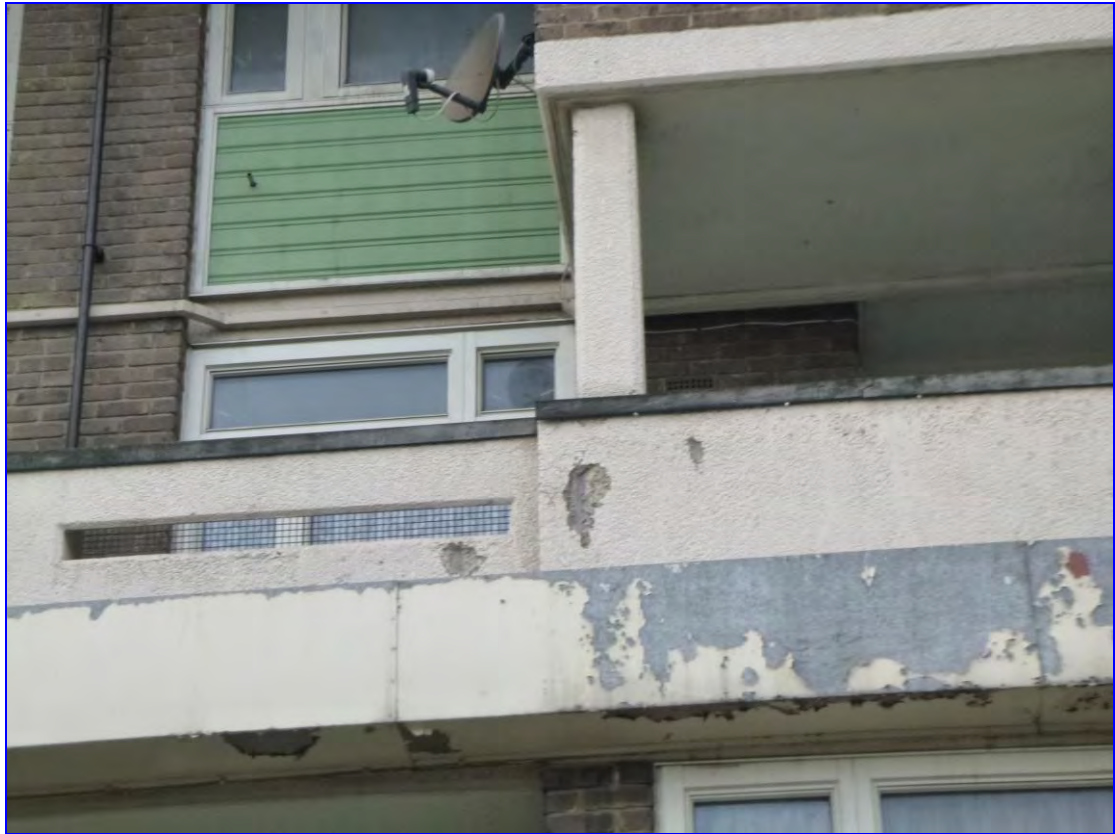
Photograph 19: Further spalling to Heversham House, with exposed rebars at spalls covered with a grey primer.

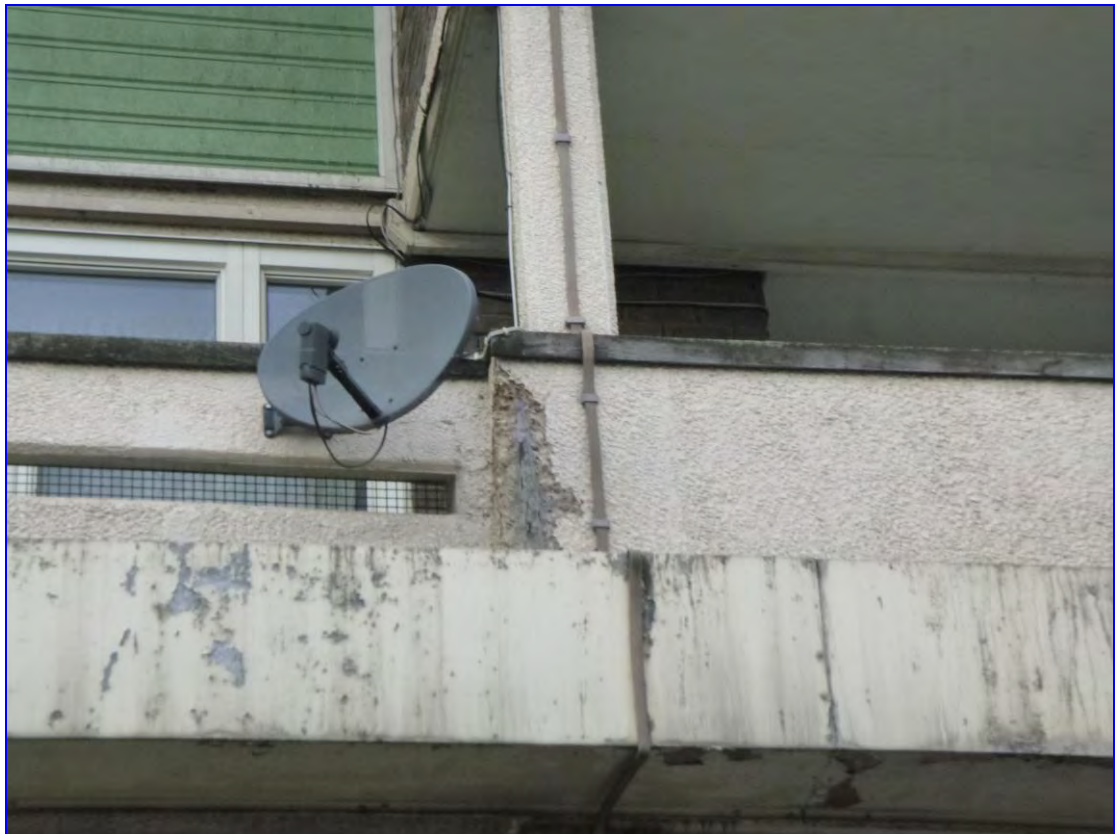
Photograph 20: Another example of spalling to Heversham House.

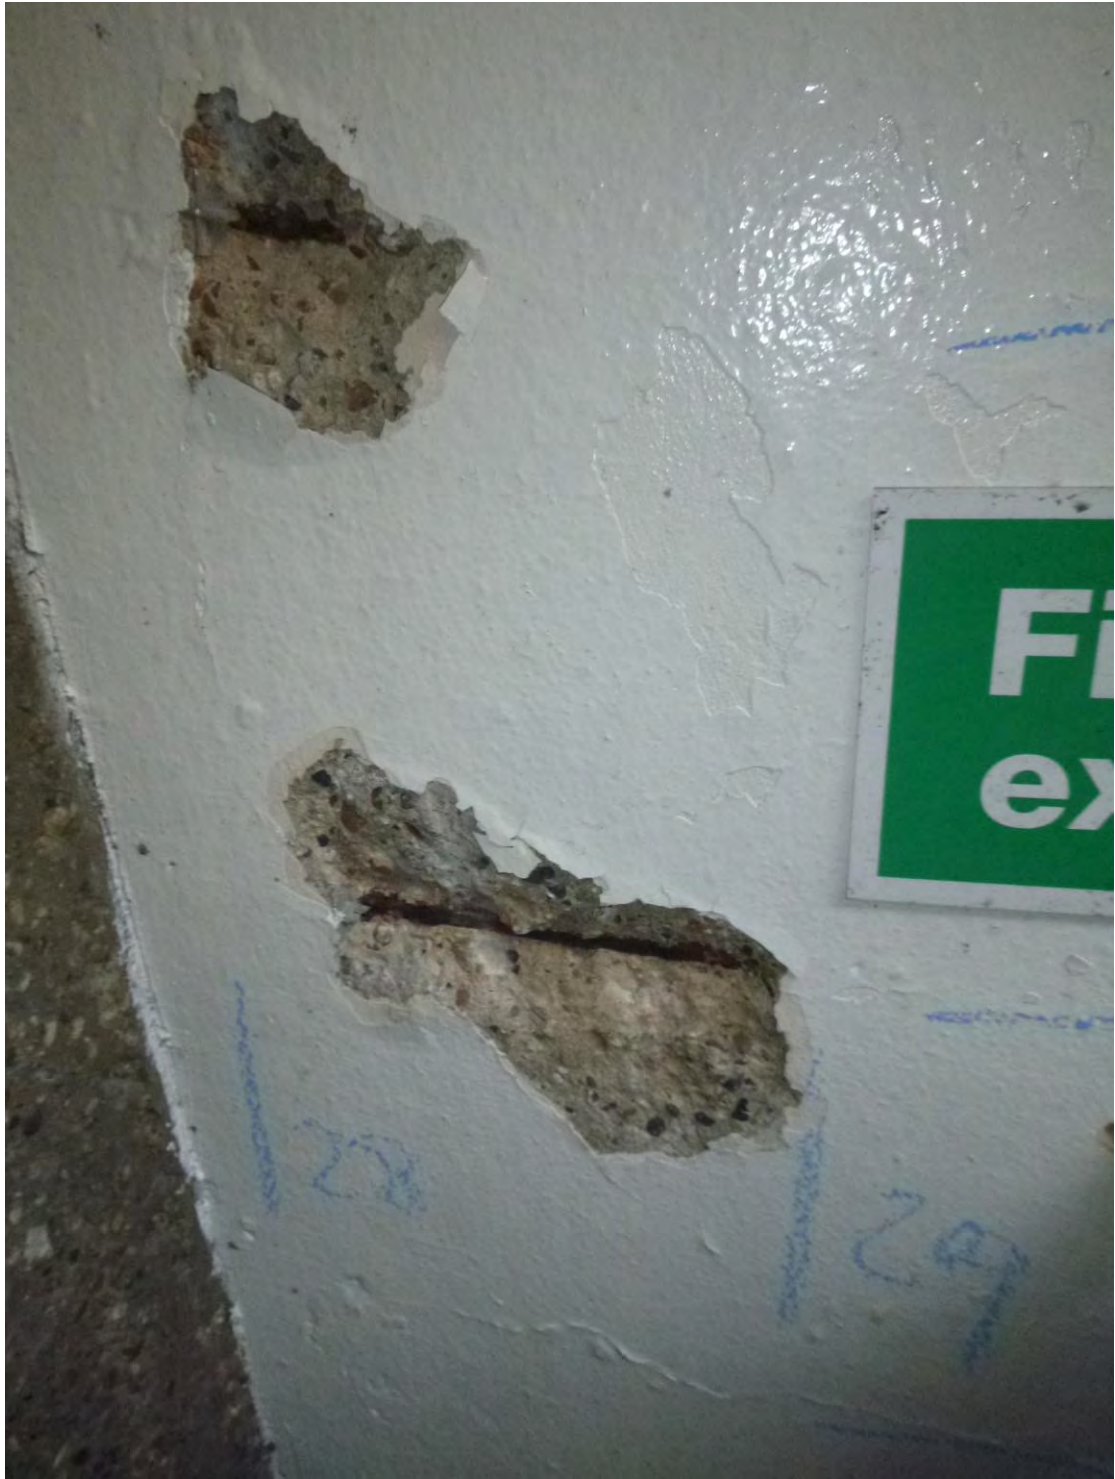
Photograph 21: Spalling to stair tower roof at TA42, on Bowness House.

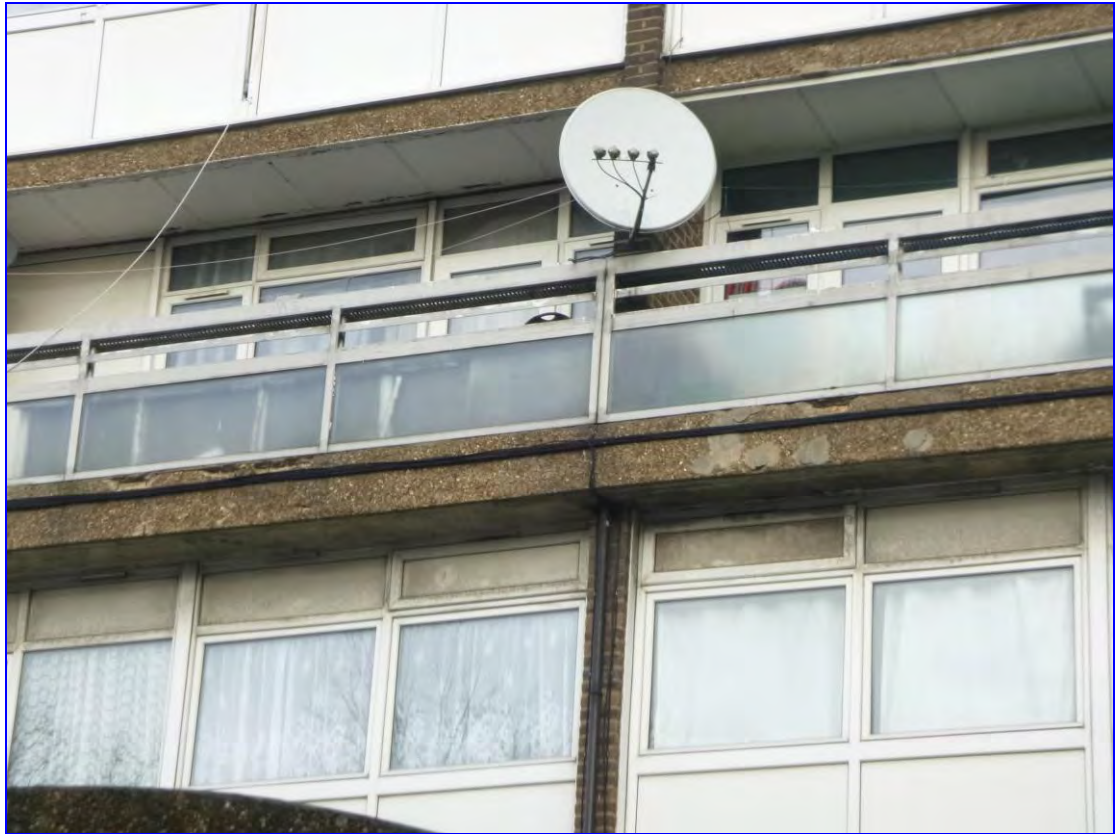
Photograph 22: Example of various spalls and previous repairs along floor beam, Bowness House.
