# Stock Condition Survey Report

Tustin Estate, London Borough of Southwark

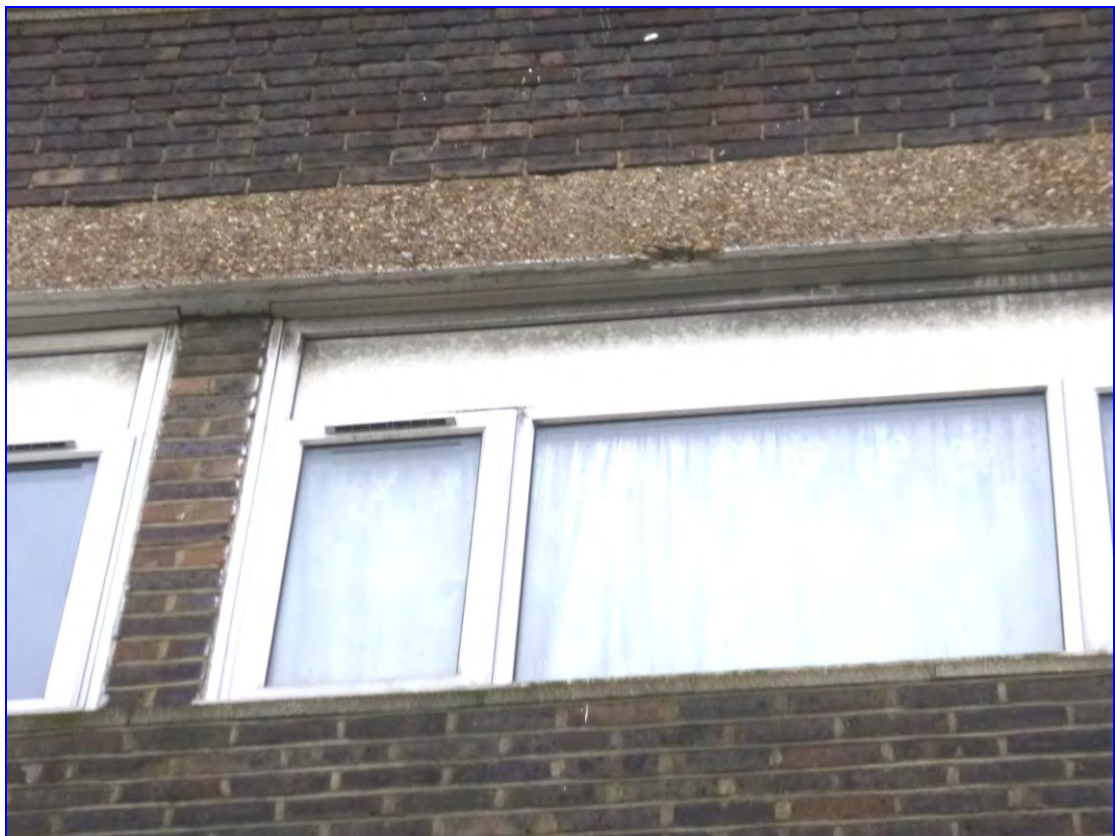
Photograph 23: A spall to a beam over a window, Bowness House.

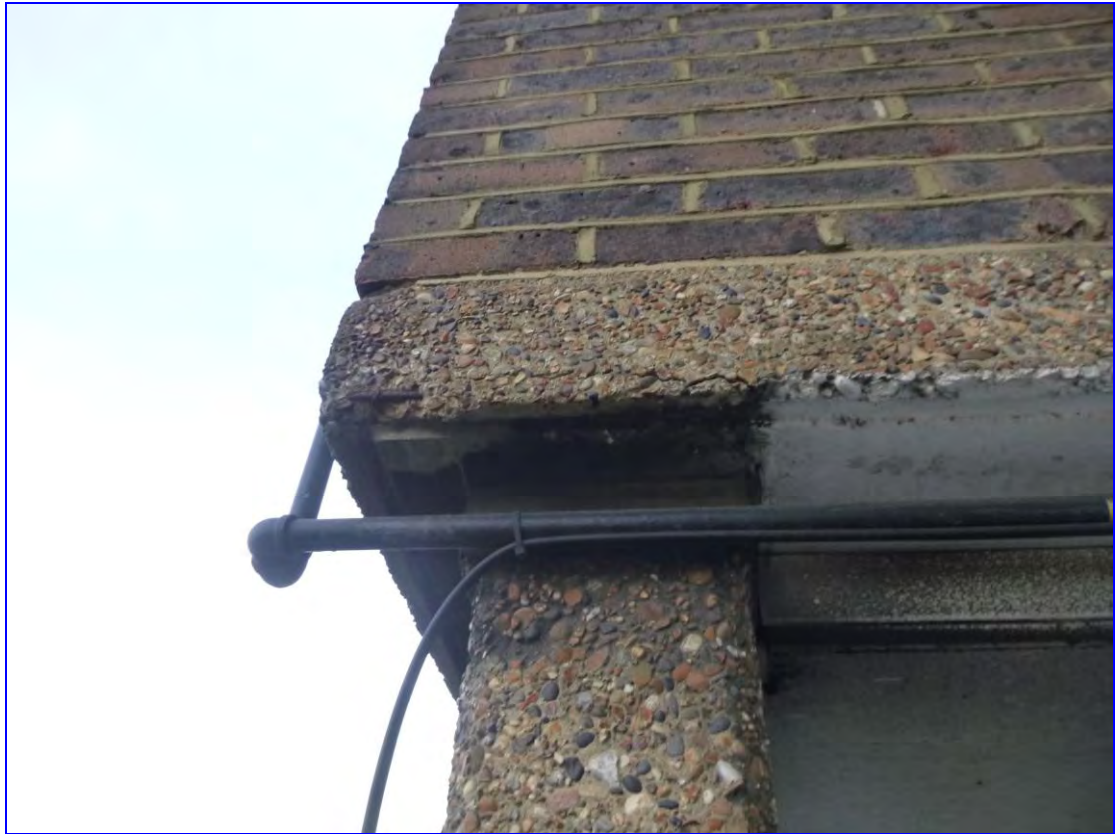
Photograph 24: Spalling and visible rebar on Bowness House.

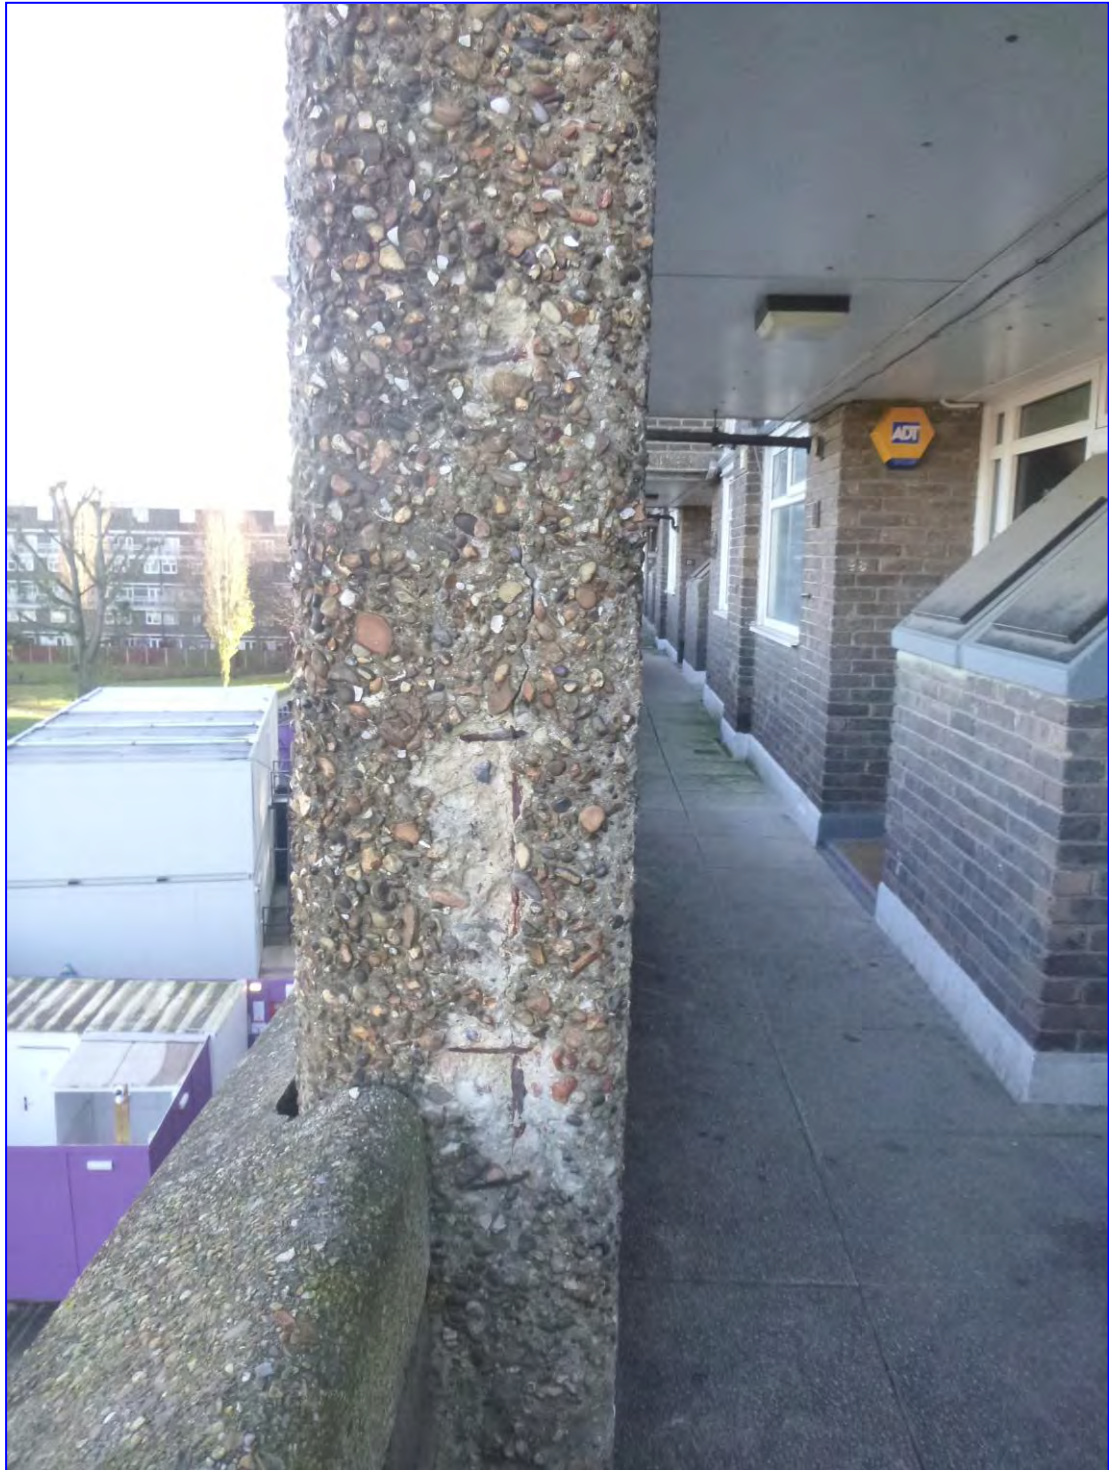
Photograph 25: Another example of spalling, here to a column on Bowness House, at TA38.

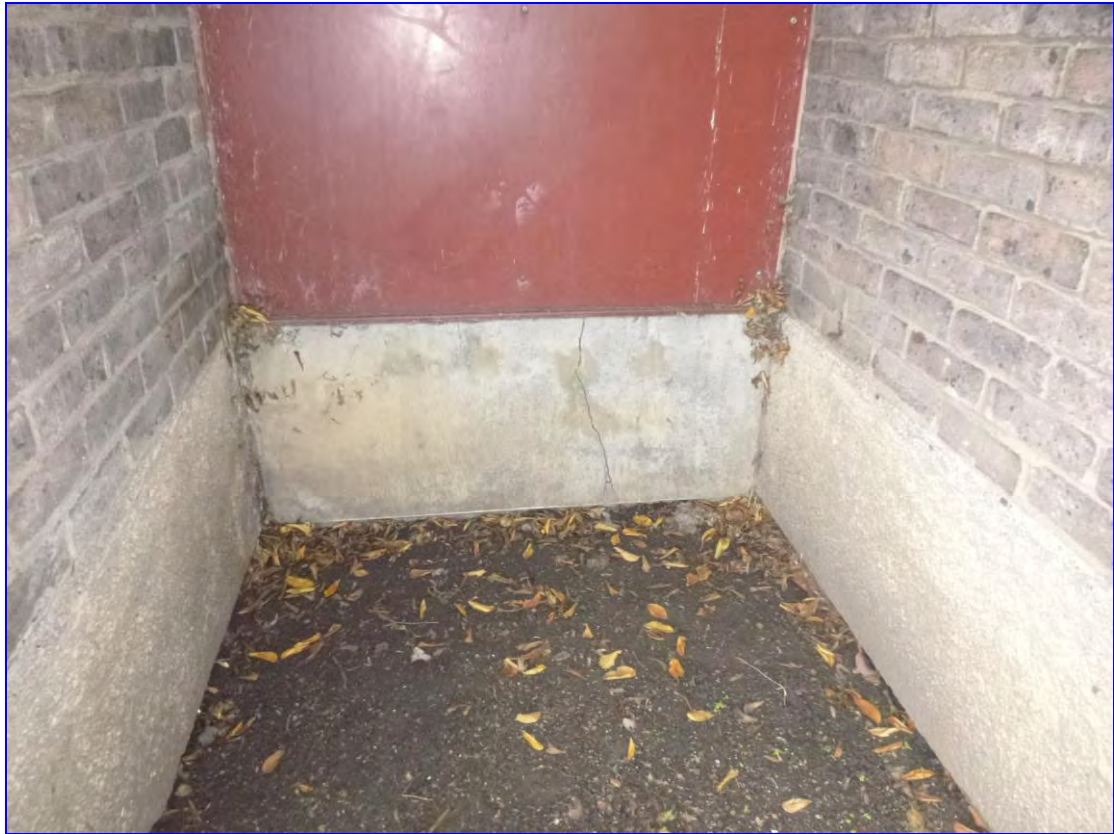
Photograph 26: Cracking to floor beam on Ullswater House.

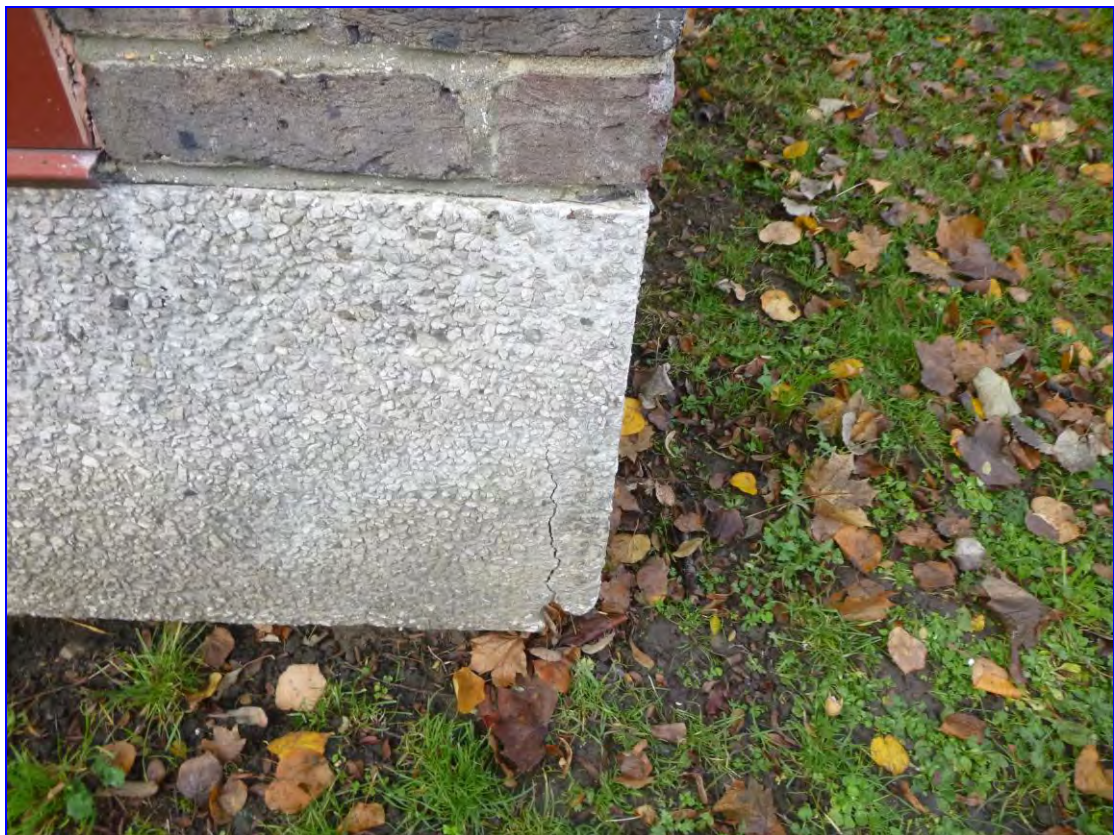
Photograph 27: A spall to a corner, pc panel, Ullswater House.

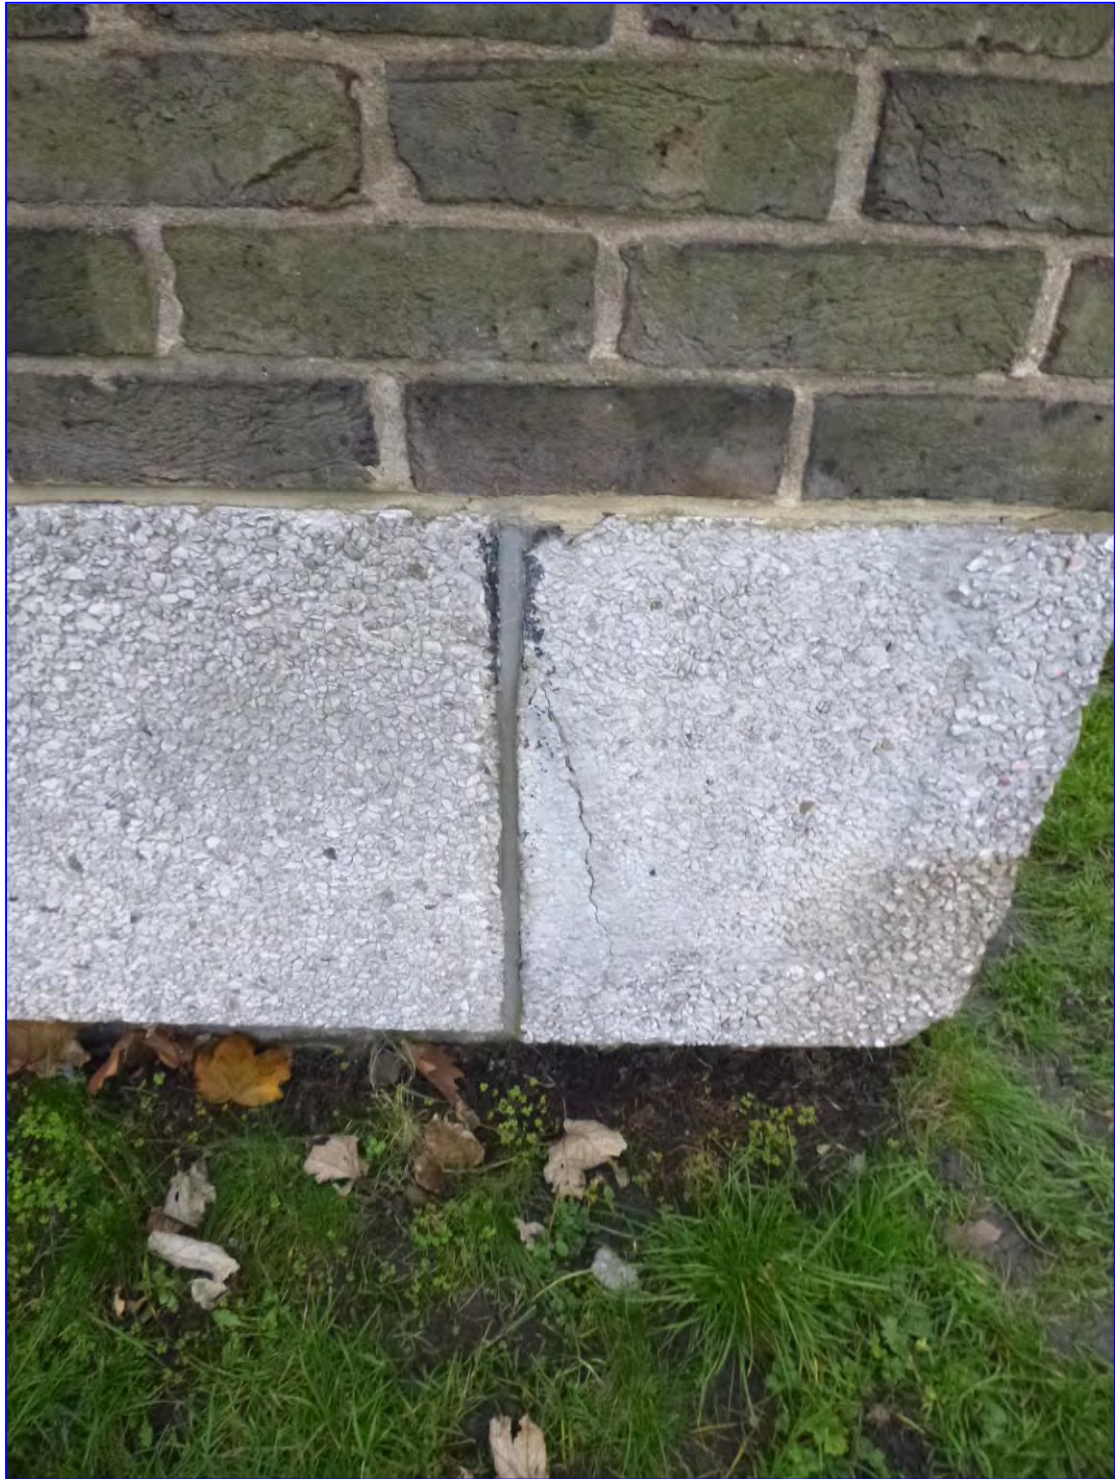
Photograph 28: Spalling to a pc panel at a joint, Hill Beck House.

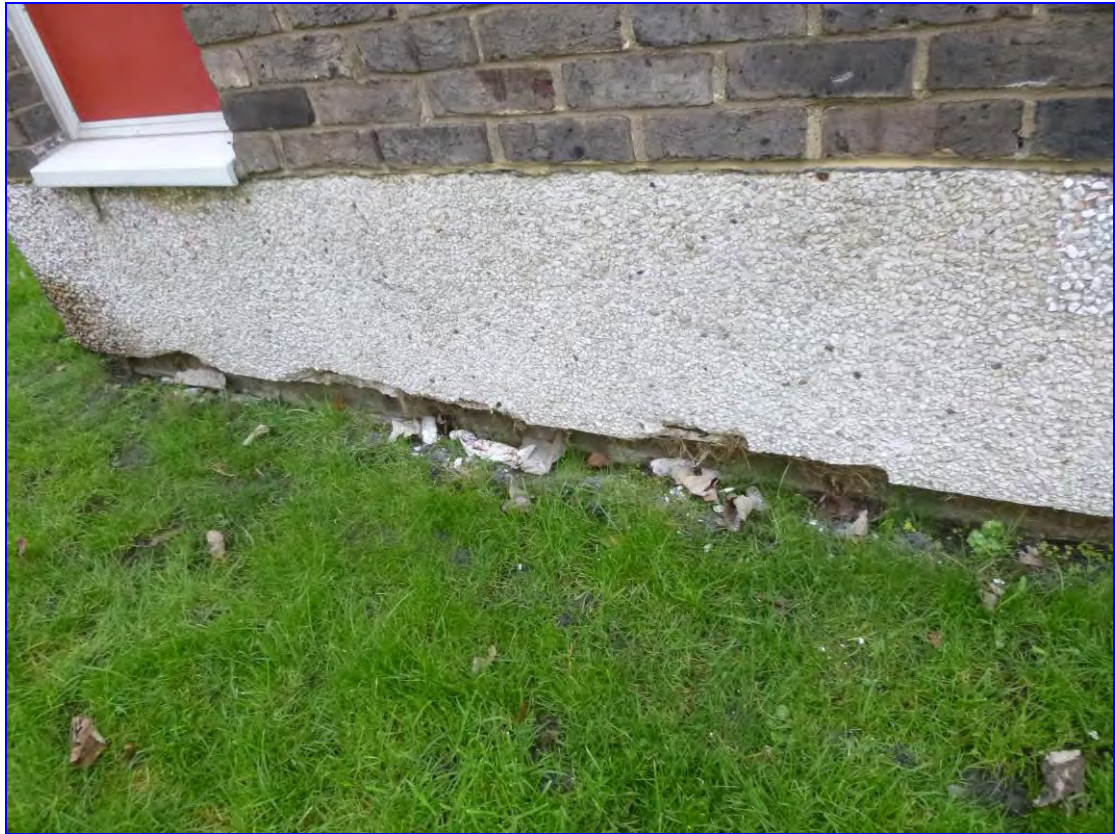
Photograph 29: Spalling along a pc panel bottom edge, Hill Beck House.

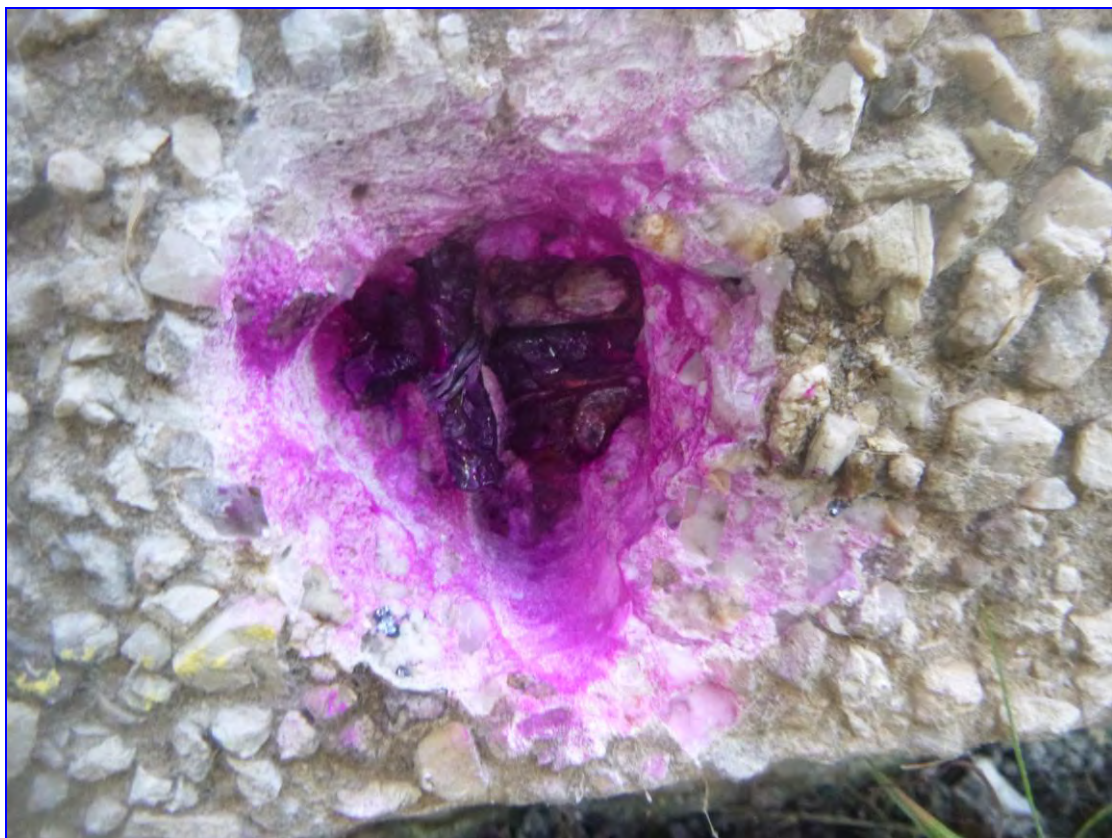
Photograph 30: The breakout at TA1, pc panel, Hill Beck House, revealing clean and passive reinforcement in alkaline concrete.

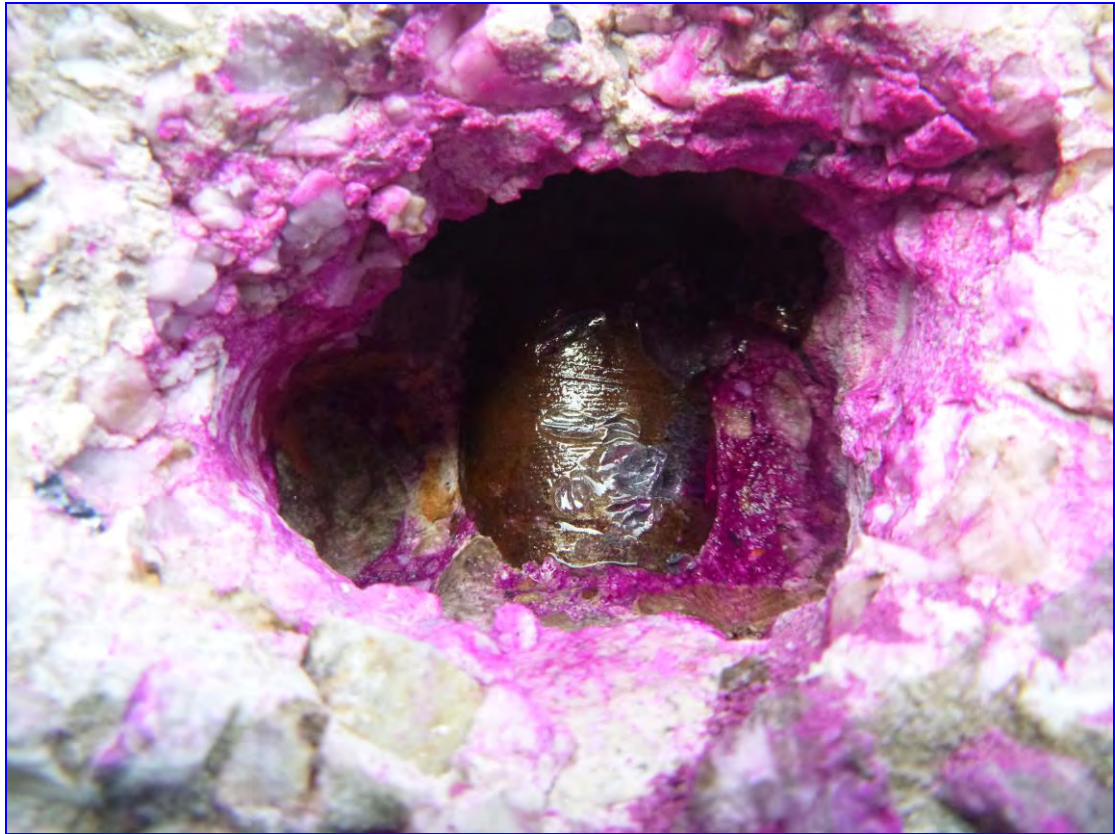
Photograph 31: The breakout at TA7, pc panel, Ullswater House, revealing a bar with slight surface corrosion where carbonation had reached the bar down a crack (central to this photo).

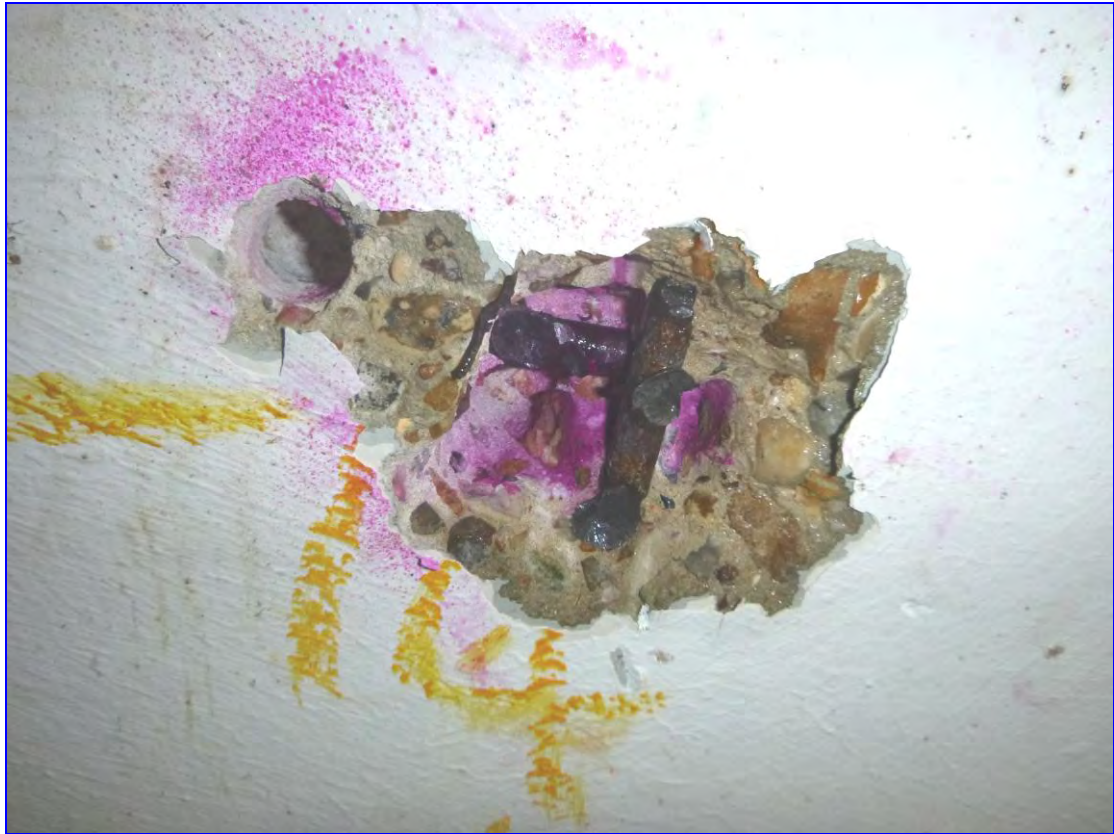
Photograph 32: The breakout at TA24, soffit, Heversham House, revealing one bar in carbonated concrete with slight surface corrosion and a bar at deeper depth in alkaline concrete and clean and passive condition.

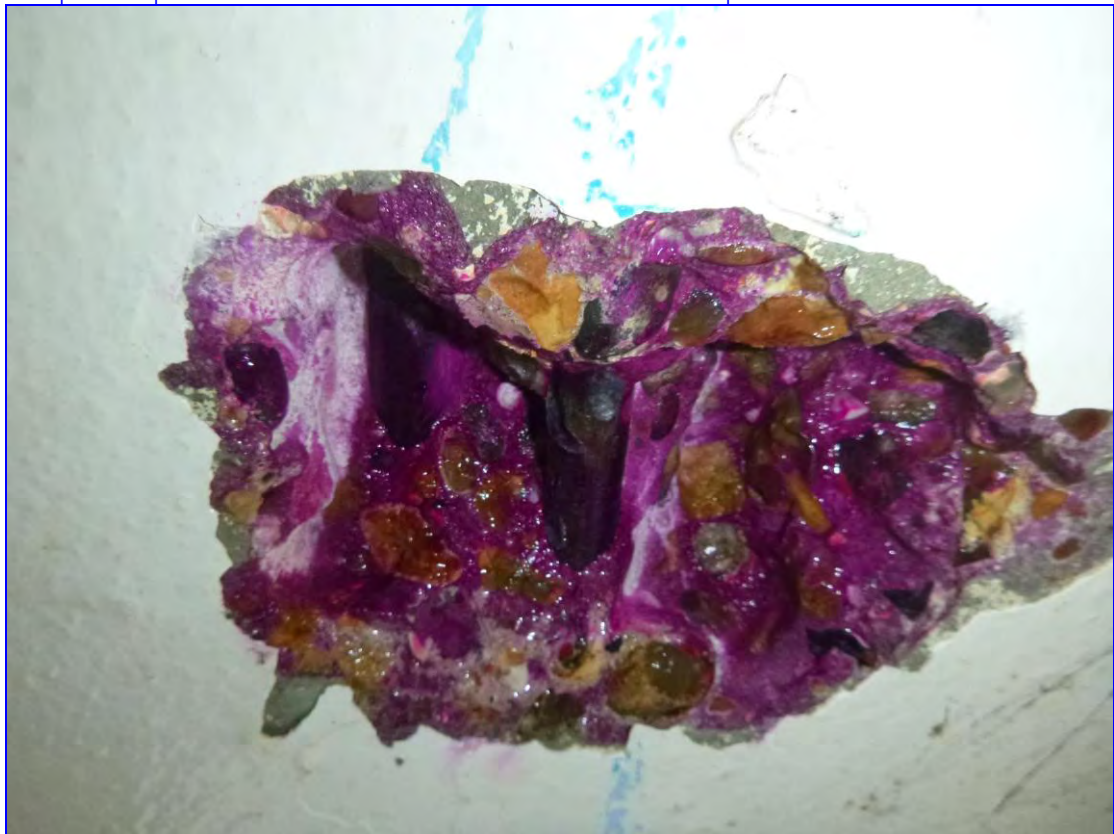
Photograph 33: The breakout at TA37, soffit, Bowness House, revealing clean and passive rebar in alkaline concrete.

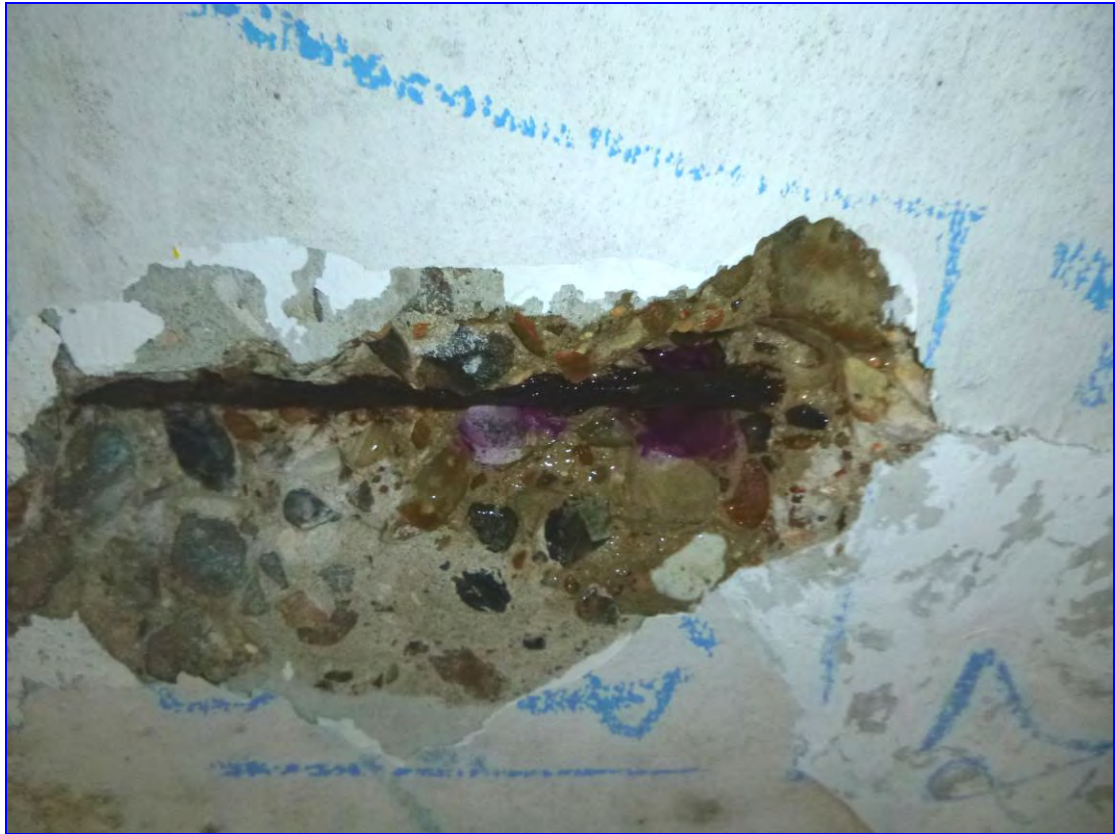
Photograph 34: The breakout at TA54, soffit, Kentmere House, revealing a bar with surface corrosion/loss of section in carbonated concrete.

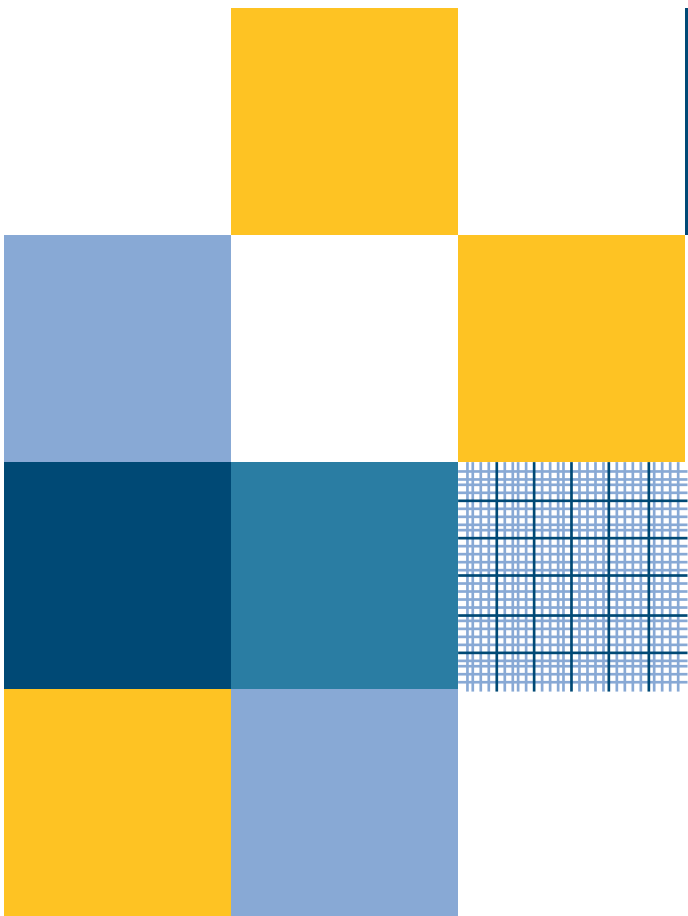
The exploratory breakouts often (more than 50%) revealed rebars with slight or surface corrosion in carbonated concrete indicated there is also a notable level of latent damage.

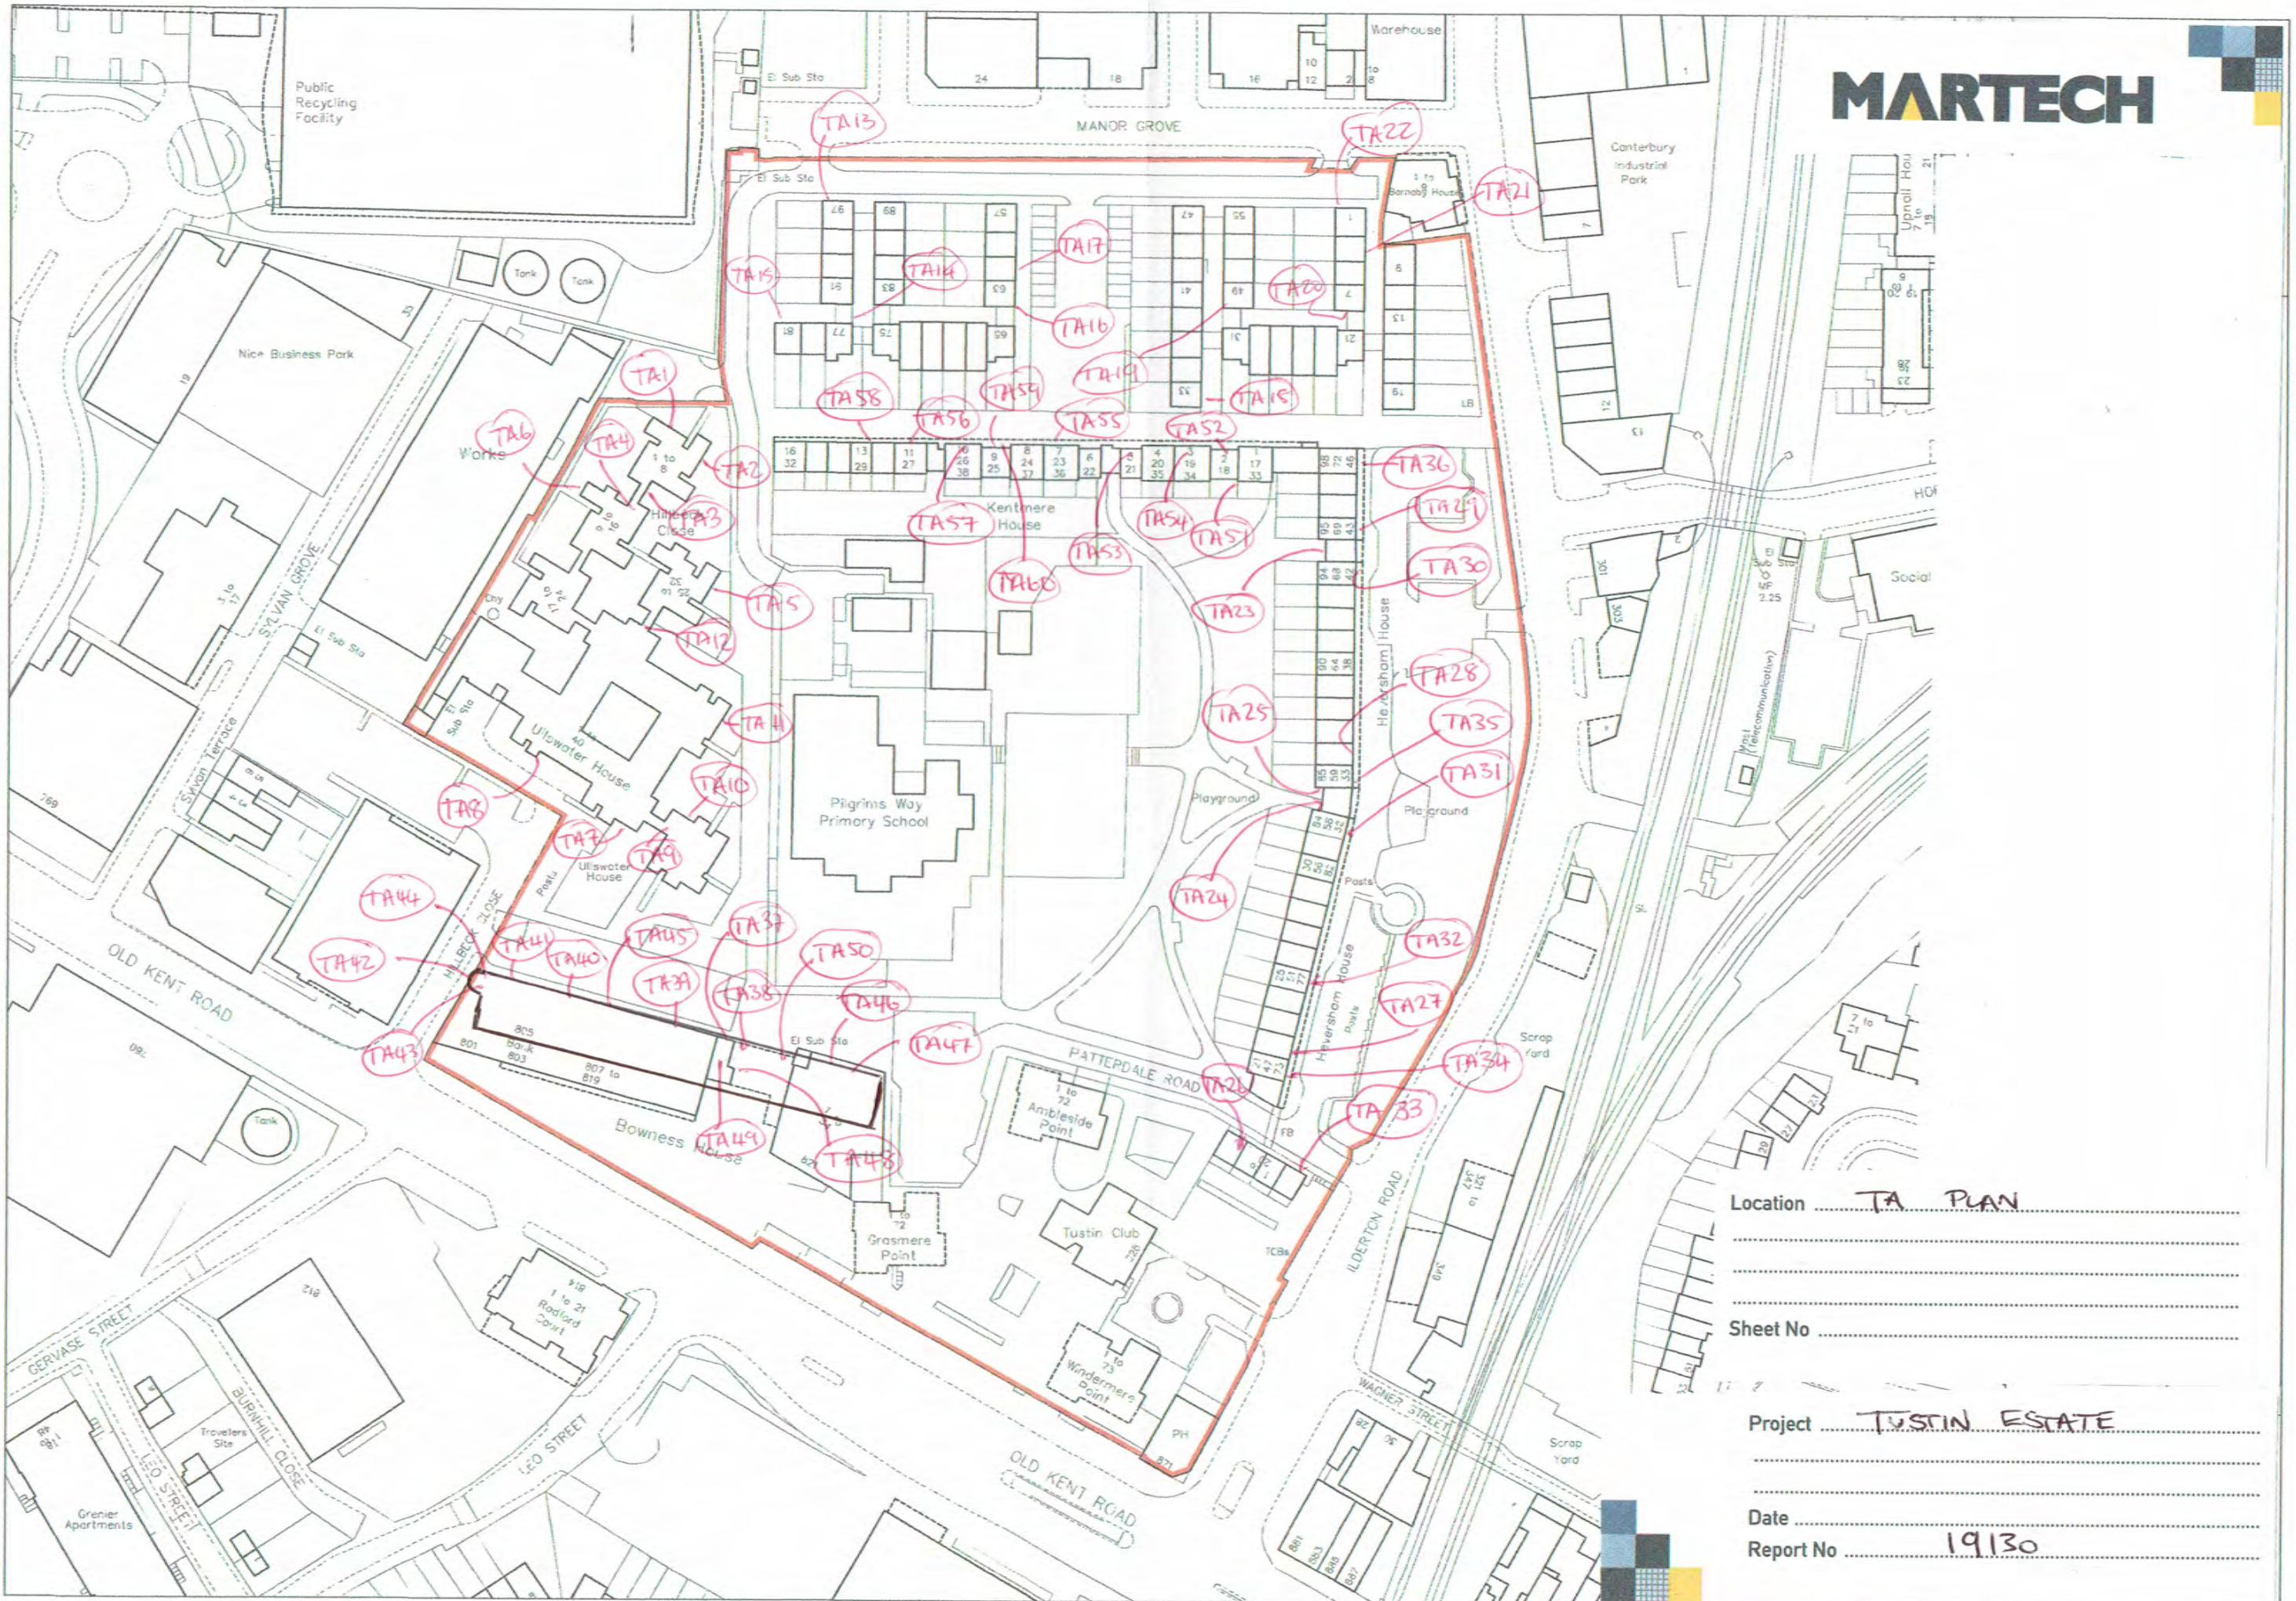
45	Rebar Location and Depth of Cover (mm)
⊕ S	Sample Location and Reference
CV	Depth of Cover (mm)
BWK	Brickwork
CB	Depth of Carbonation (mm)
C+P	Clean and Passive Steel
LOP	Loss of passivity
SP	Spall
PR	Previous Repair
FPR	Failed Previous Repair
TW	Tie Wire
RS	Rust Spot/Stain
PY	Pyrite
B/O	Breakout to Expose Reinforcement
FM	Facing Mix
BM	Backing Mix
{ c	Crack
VS	Visible Steel
BE	Bar end
⊕ C1	Core Sample Location and Reference
SSC	Slight Surface Corrosion
SC	Surface Corrosion
H	Hollow

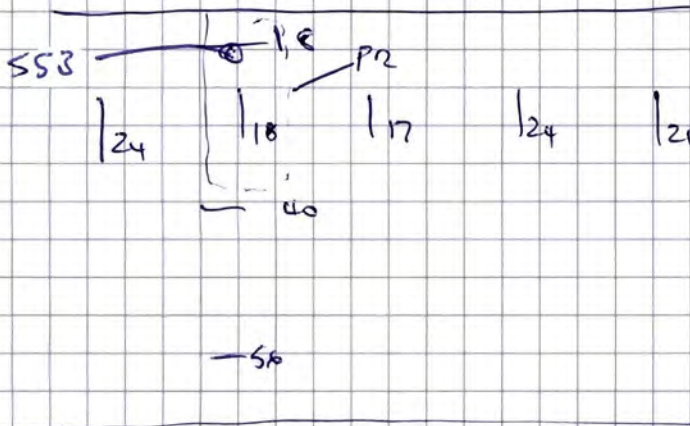
SS3 1x12  $\phi$  plan vert  
CV 20m  
1x10  $\phi$  plan hbk  
CV 5m  
CB 570  
SSC / LOS

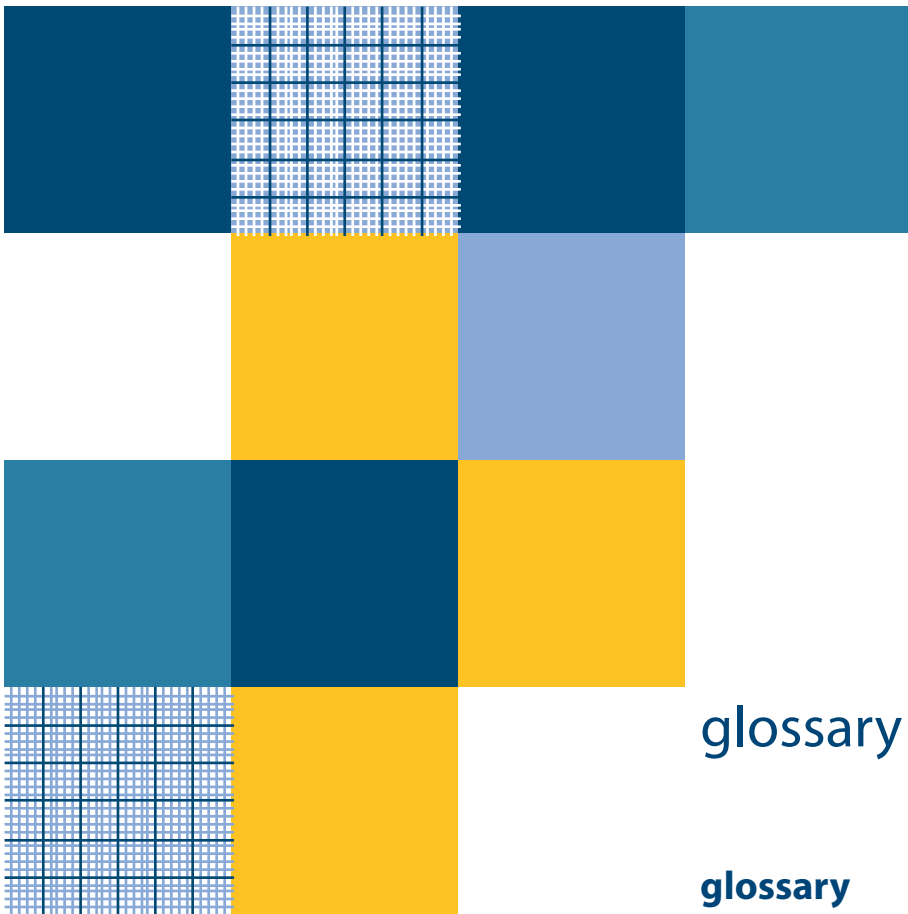
In our opinion the preferred route forward, in procuring the necessary repair services, is in the formation of partnerships and term contracts with a suitable contractor. It is important to seek a satisfactory outcome for all **parties, in which the client's needs and wishes are fully** encompassed. Negotiation and Construction Partnering, as advocated in the Egan Report, should really take a preference over the traditional method of competitive tendering, which in the final analysis can only serve to reduce every aspect of a job to its lowest common denominator.

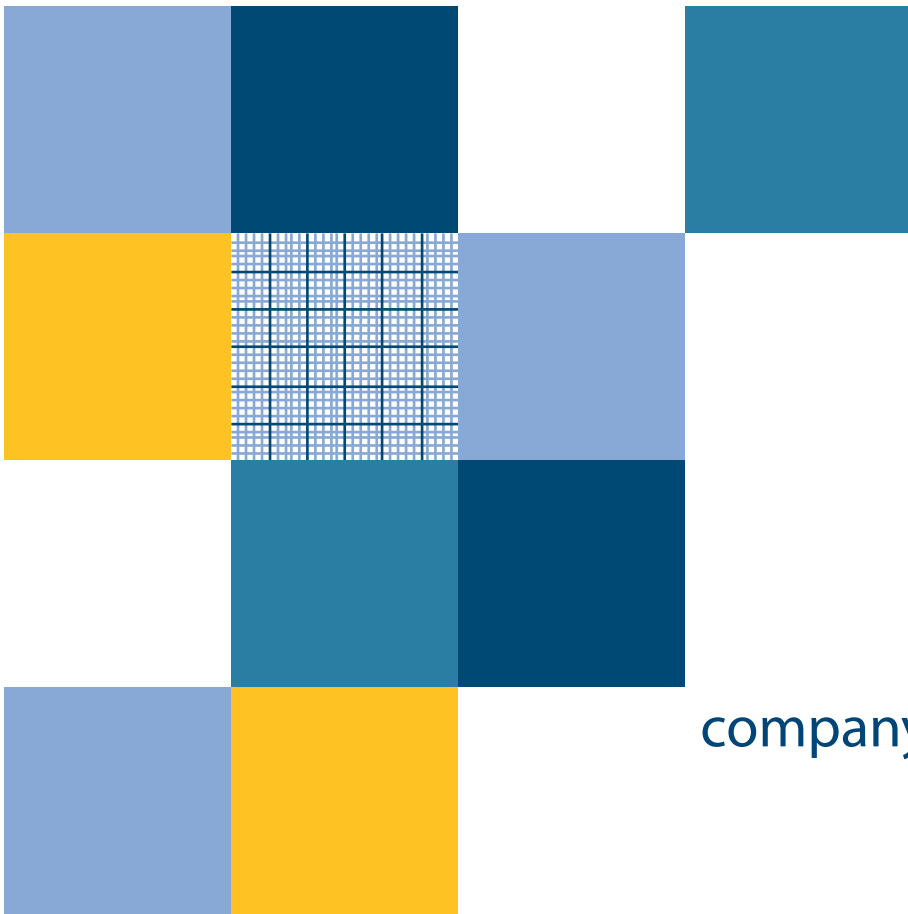
11. BRE Report BR 254 Repair and Maintenance of Reinforced Concrete.

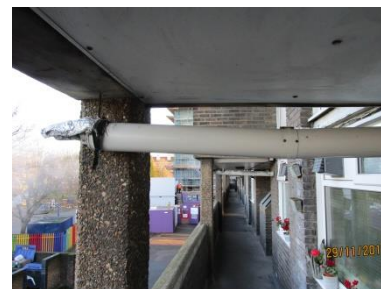
The Hot Water Services cylinders are fed by a Cold Water Feed Tank located above them. The system may provide poor pressure to the taps but has the advantage of providing each dwelling with some water storage and a local means for the open vented Hot water cylinder to expand to.

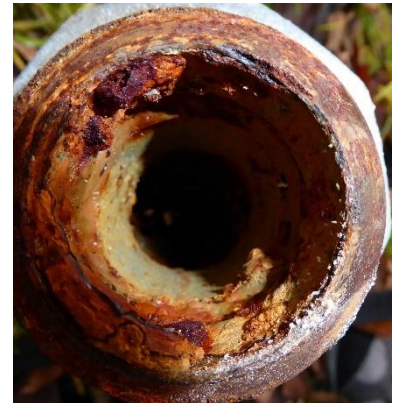
Additional evidence of galvanised steel corrosion can be found in the storage tanks which are also formed in this material.

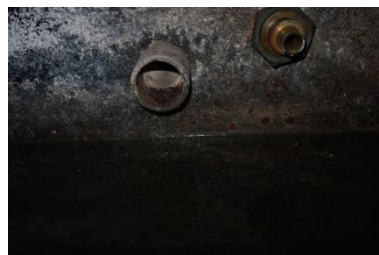
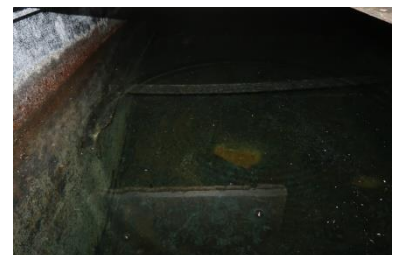
As the Water Services are a consumable service we consider the pipework condition critical.

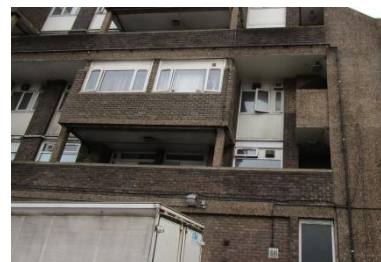
The gas distribution pipework is not the responsibility of Southwark Council and any recommendations in relation to this distribution are for the gas supplier to carry out. However, the gas services within the dwellings, is the responsibility of the Council or Leaseholder and if ventilation to a riser is required Southwark have the responsibility to ensure it is fitted.

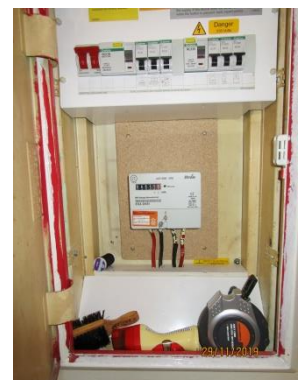
#### 4.1.5 **Electrical Installation Condition**

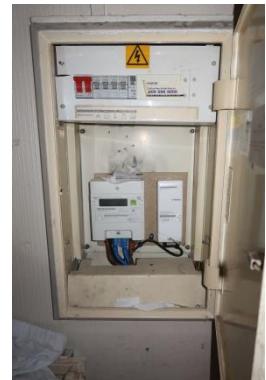
#### 4.1.6 **Electrical System Recommendations**

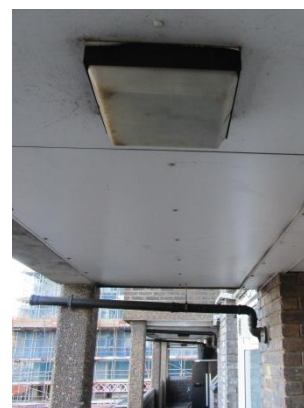
### 4.2.1 Communal Lighting System Recommendations and Budget

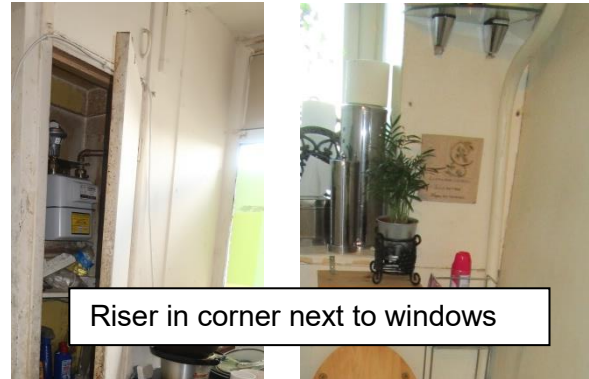
Life expectancy of Cast Iron soil pipes is listed within CIBSE Guide M at 35 years although many manufacturers quote life expectancies of up to 100 Years. PVC has a life of 20 years. Much of the modified local PVC drains age cannot be determined although some of the fittings have “yellowed” and appear over 20 years old.

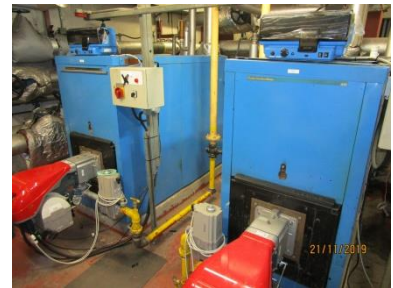
From the high level within the Boiler House the pipework exits the building and runs externally to Heversham House along the first floor balcony. It is unclear how it rises to the upper levels.

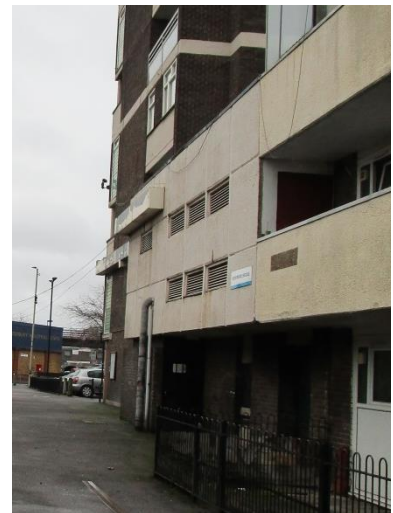
The Boiler House has a central control panel for the plant with separate BMS system panel. There are two sets of run & standby pumps serving the system. They provide 100% backup should a pump fail and are designed with different flow rates to allow a summer / winter use option selected on the control panel.

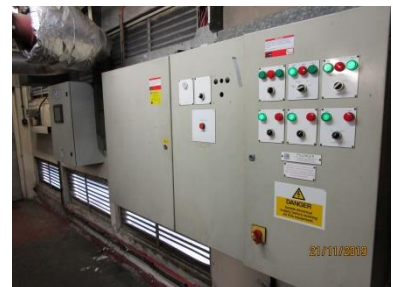
### 3.1.2 System Condition

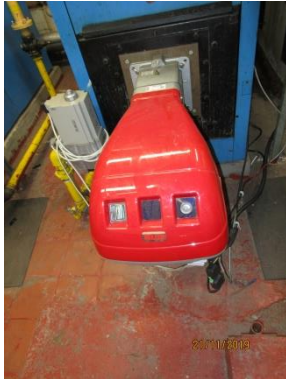
The boilers own control panels failed and these have also been replaced.

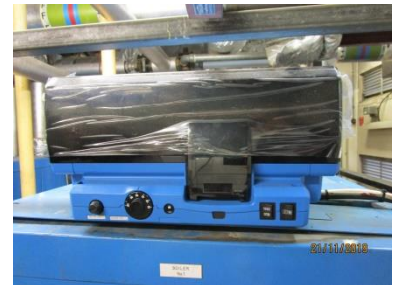
New Boiler Controller

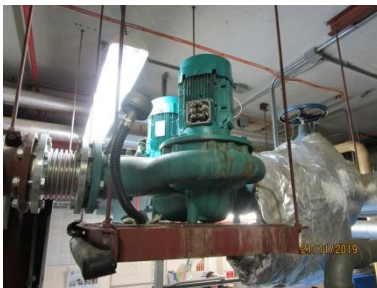
All pump-sets have been replaced and some of these have had further motor replacements.

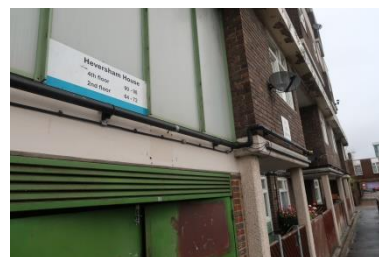
Within Kentmere House our survey was unable to locate the gas distribution pipework route through the building. This is a concern as the pipework may be concealed within service risers which must be ventilated.

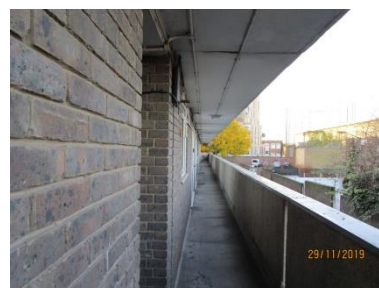
The gas distribution services are not the responsibility of Southwark Council and any recommendations in relation to this distribution are for the gas supplier to carry out. However, the gas services within the dwellings, is the responsibility of the Council or Leaseholder.

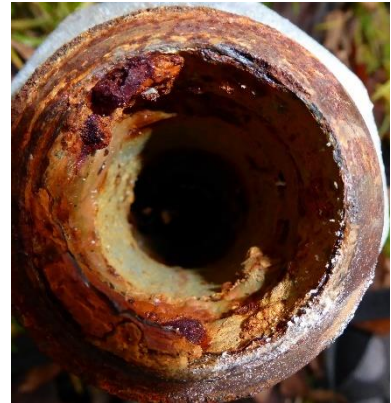
Additional evidence of galvanised steel corrosion can be found in the storage tanks from Kentmere House which are also formed in this material.

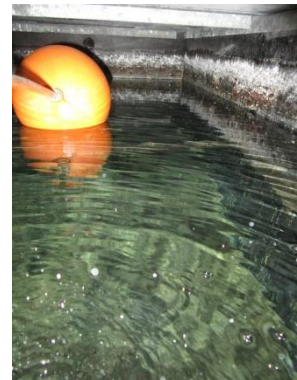
As the Water Services are a consumable service we consider the pipework condition critical.

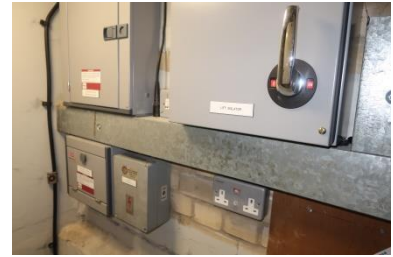
#### 3.4.2.2. Kentmere House

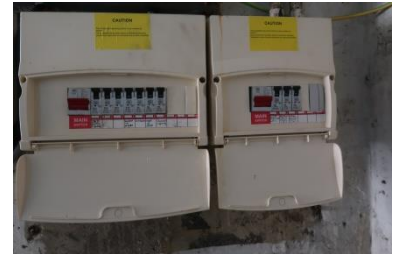
The wiring found within the system was PVC but using the older red and black coding dating it to before 2004. The new distribution boards are between 10-15 years old and appear to have installed to existing circuits.

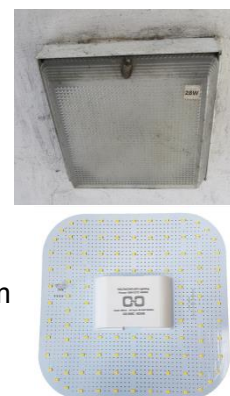
It is unclear if the wiring had been replaced at this time.
