# Stock Condition Survey Report

Tustin Estate, London Borough of Southwark

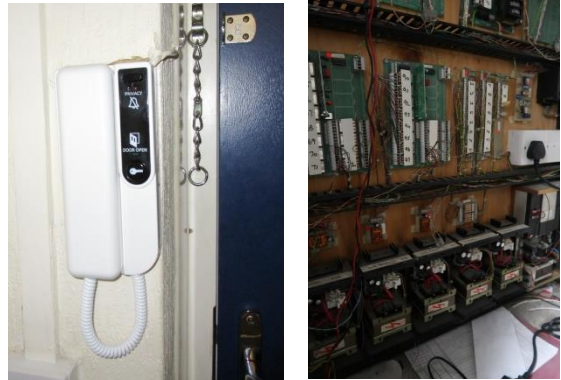
The Kentmere House system was not located during the surveys.

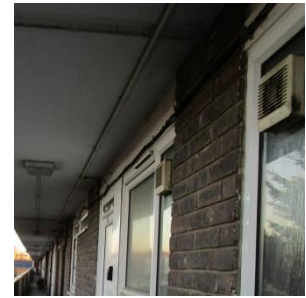
The fans are varied in age, condition and type.

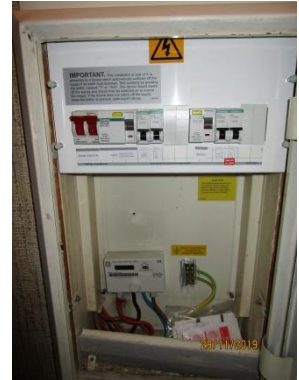
### 5.1.2 Electrical Installation Condition

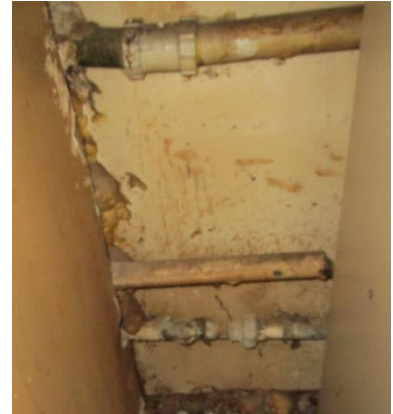
Kentmere House appears to have two SVP's to each dwelling one to the Bathroom one to the kitchen.

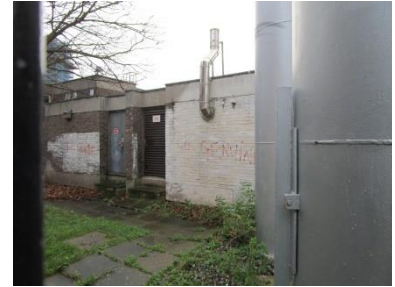
The Boiler House systems comprise of the boilers, HWS calorifiers, primary pump-set for the boiler house plant, secondary pump-set serving the radiators within Ullswater House and Hillbeck Close, the HWS circulating pump and a pressurisation unit.

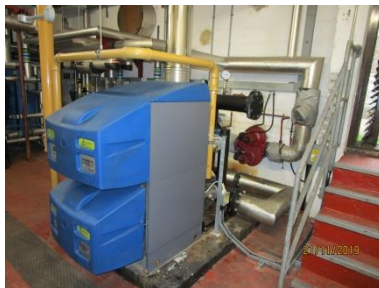
Two gas fired modular boilers to provide heating and two HWS calorifiers provide the hot water.

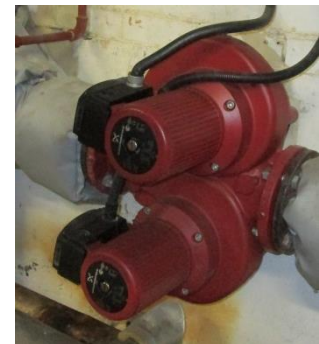
The distribution pumps are from the 1992 installation albeit with replacement motors since originally installed.

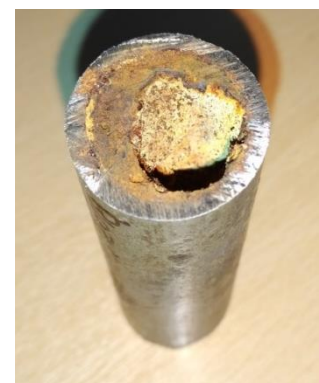
The Photo is of pipework from the building MCCE are currently working on to replace the water Services pipework. This building is within the Lambeth area and is of similar age. The pipe was from a hot water service and was completely dry when removed from a live system.

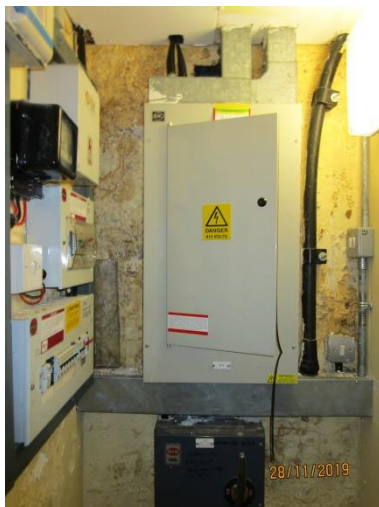
Older Distribution Board

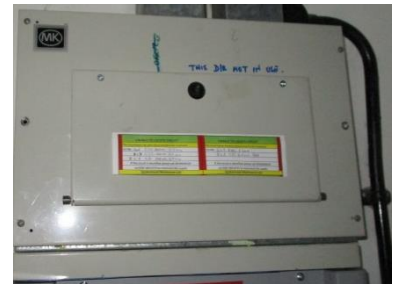
The lateral mains were not visible for inspection.

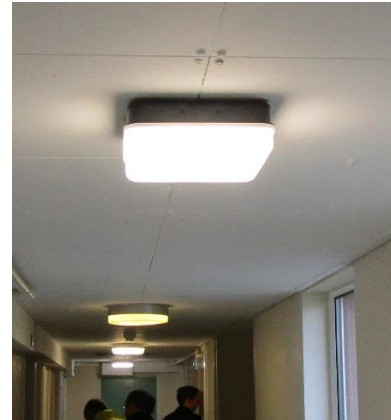
The fittings did not have emergency lighting and so separate bulkheads have been installed to provide the required cover.

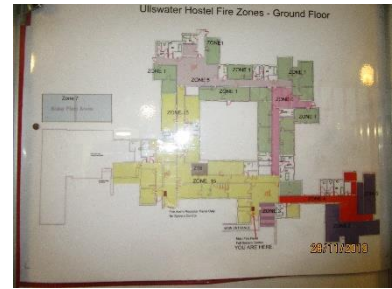
#### 3.6.2 Fire Alarm System Recommendations

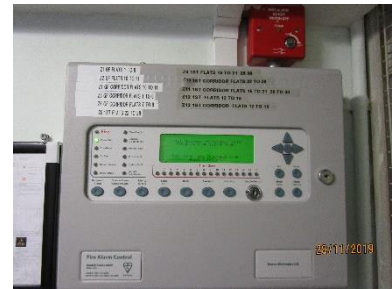
The main control panel we have shown in year 12 allowing for it to last 20 years. At this time all call points should be validated and replaced if required.

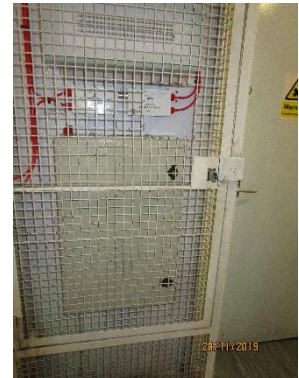
#### 3.7.2 Sprinkler System Recommendations

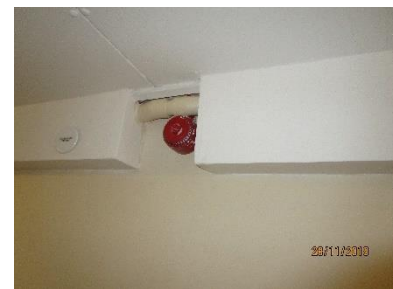
The main control panel we have shown in year 12 allowing for it to last 20 years.

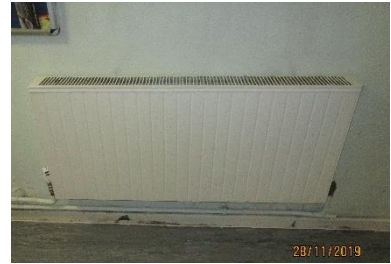
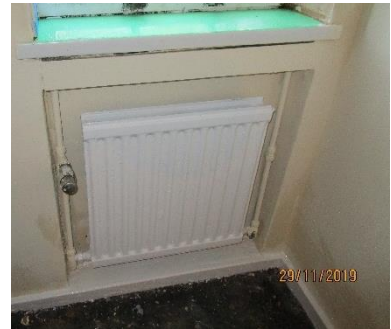
#### 4.1.1 Heating System Recommendations

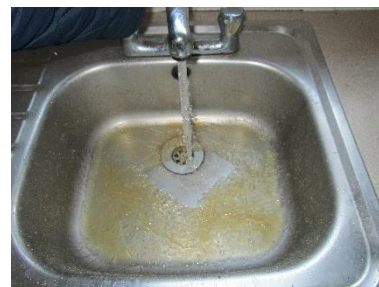
### 4.2.3 Water Services System Condition Recommendations

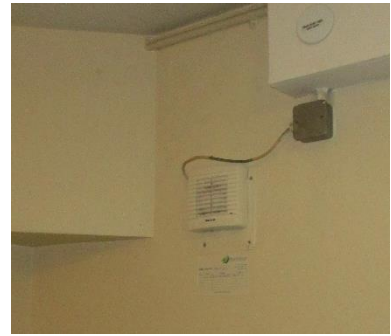
#### 4.3.1 Ventilation Systems Recommendations

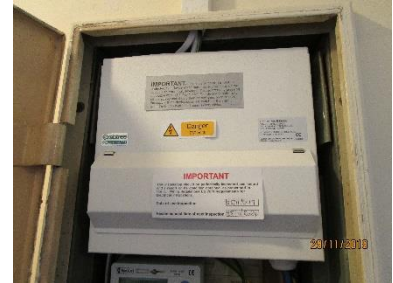
Below the consumer unit the connection to the meter has been replaced but the lateral mains going into the cut-out are clearly significantly older and very likely to be the original installation from 1968.

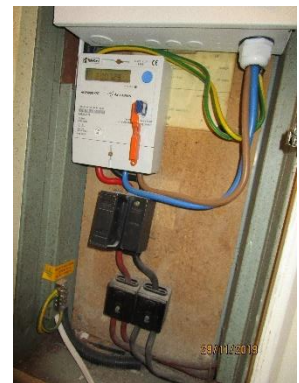
This dwelling appears to have been rewired with all wiring carried out in surface mounted PVC mini-trunking

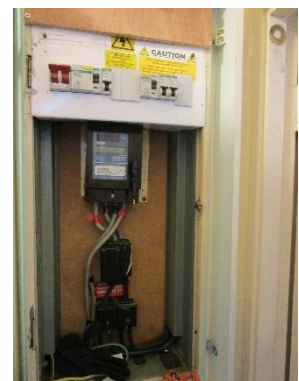
### 5.1.2 Electrical Installation Condition

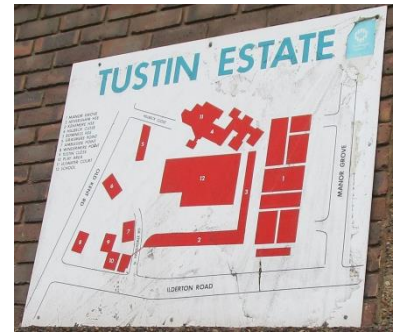
## 1.2 Project Brief

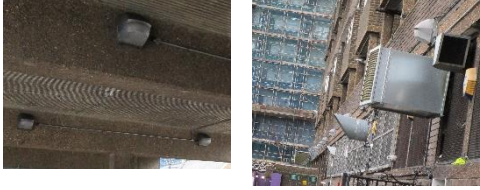
Fittings are modern LED type fittings	Recently installed using existing conduit but unclear if the wiring was replaced at the same time.
Bin enclosure

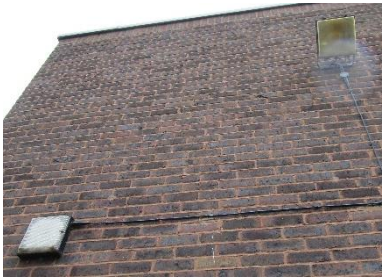
<p data-bbox="911 338 1070 533">High Pressure Sodium Fitting and LED square fitting</p>	<p data-bbox="1126 338 1442 465">It is unclear if the floodlight still operates. The new LED lighting is fitted to all blocks.</p> <p data-bbox="1126 506 1410 633">This light throws outward and does not illuminate the pavement effectively.</p>
Pedestrian walkways between blocks

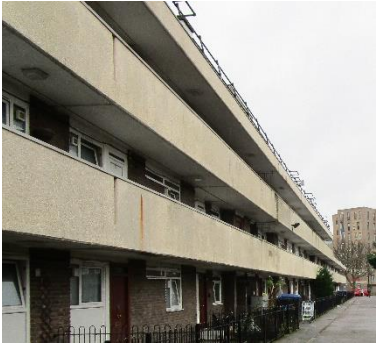
<p data-bbox="523 712 1109 810">The only external estate light is over the car park area. This is a high pressure sodium fitting.</p>	<p data-bbox="1129 367 1412 434">Over 15 years old, at end of life.</p> <p data-bbox="1129 470 1417 600">The pedestrian walkway relies on the balcony lighting for illumination.</p>

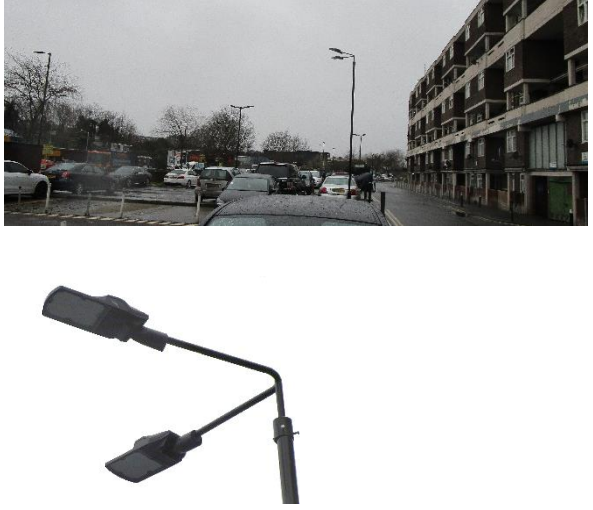
<p>Modern LED lighting on poles to the car park area.</p>	<p>Over 15 years old, at end of life.</p> <p>The pedestrian walkway relies on the balcony lighting for illumination.</p>
<p>Ground floor flat entrances</p>

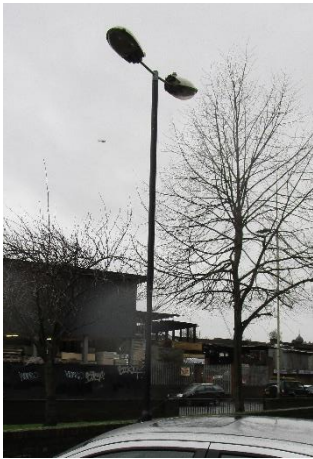
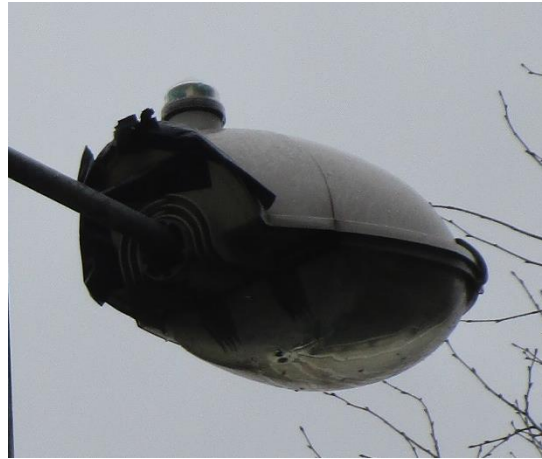
With these fittings are the typical type use on the estate. They are High Pressure Sodium lamps and are complete with daylight sensors.
