Bermondsey Street Conservation Area The Character and Appearance of the Area

Bermondsey Street (south)

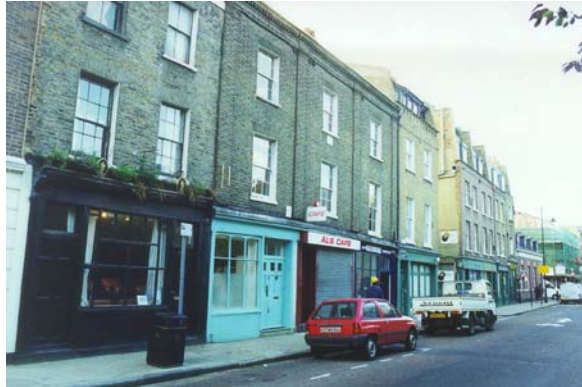
- 3.2.8. Between Leathermarket Street and Lamb Walk the buildings provide a very consistent street frontage in a group centred on listed buildings at nos. 124-132 (dated 1828). Originally houses, they have a three-storey cornice line and simple shop fronts linked by a common fascia line. The windows of the upper floors create a simple unifying rhythm. Other buildings in the block have been extended to a mansard storey set slightly back but retain the dominant line of the cornice. New residential development at 134 to 140 continues the line of the shop fronts as a stuccoed ground floor elevation.

Figure 21 124-132 Bermondsey Street: early 19th century houses converted to shops and now listed. The picture shows the importance of the original cornice line and the impact of modest roof extensions on neighbouring buildings.

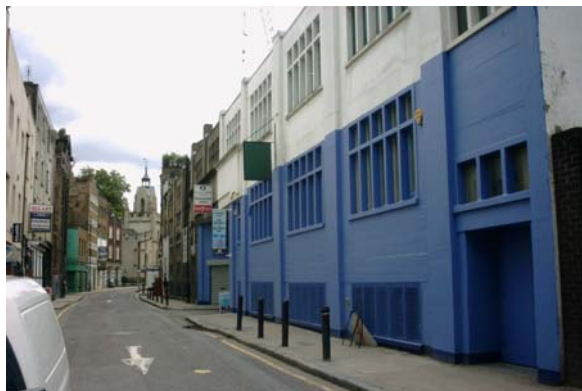
- 3.2.9. South of Lamb Walk, the yard to a large modern warehouse interrupts the continuity of the western street façade. It is re-established by the frontage of early 20th century concrete buildings at 156-170, but the character of the buildings at street level is harsh, with lower ground floor windows on the level of the pavement necessarily protected by mesh screens, and upper floor windows well above head height. The original surface was badly stained, but the northern half of the buildings have been painted brightly, which lifts its heavy appearance and brings a little more vitality to the street scene.

Figure 22 Looking south to St. Mary Magdalene, showing concrete buildings at 156-170 Bermondsey Street, with repaired and painted façades.

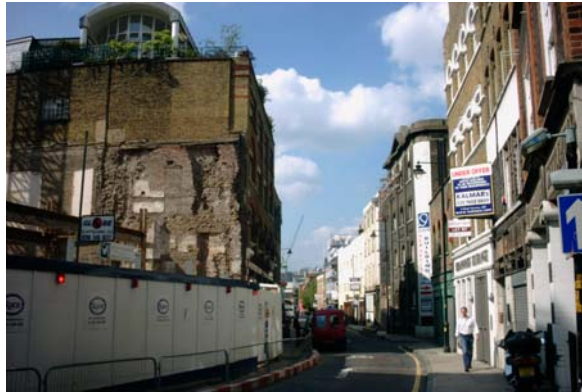
four storey former cloth factory at No. 173 on the corner of Newham's Row. The street here has a canyon-like quality that derives from a tight height to width ratio of 2:1, and it retains a strongly industrial character. Buildings on the western side are much altered by plastering and window modifications but remain in warehouse use with doorways and high windowsills dominating at street level.

Figure 23 *Industrial character of southern Bermondsey Street; but under pressure for redevelopment (see 0 below). The corner building at No. 173 is prominent in the centre of the picture.*

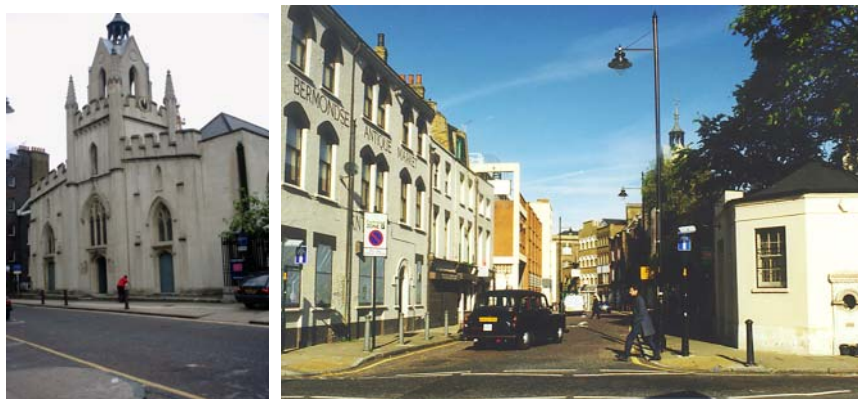
3.2.11. The focus of the southern end of Bermondsey Street is the Church of St. Mary Magdalene because of its location on the outside of the bend in Bermondsey Street. As important is the prominence of its belfry above the rooflines of adjacent warehouses, such that it is often sunlit when shadows are cast in the narrow street. The church itself is unusual in its painted stucco and Gothick detail, after remodelling by George Porter in 1830; its Grade II* listing describes it as “playful”, and Pevsner as “gimcrack but charming, wholly unscholarly”. Its architectural importance is for Charles Stanton’s interiors (1675-9) modelled on Wren’s St. Martin’s, Ludgate, and the building is by any description a surprising contrast to the character of the warehouses around it with their simple, regular brick designs. It is also part of the wider context of connected buildings, including the rectory and 191 Bermondsey Street and the churchyard enclosure with railings and stuccoed masonry, which includes the early 19th century watch-house on the corner of Abbey Street.

Figure 24 *(left) St. Mary Magdalene: an eccentric façade is in contrast to the style and scale of Bermondsey Street’s warehouses and belies an important 17th century interior.*

Figure 25 *(right) Bermondsey Street from Abbey Street, with the corner block on Long Lane and the watch-house at the corner of the churchyard.*

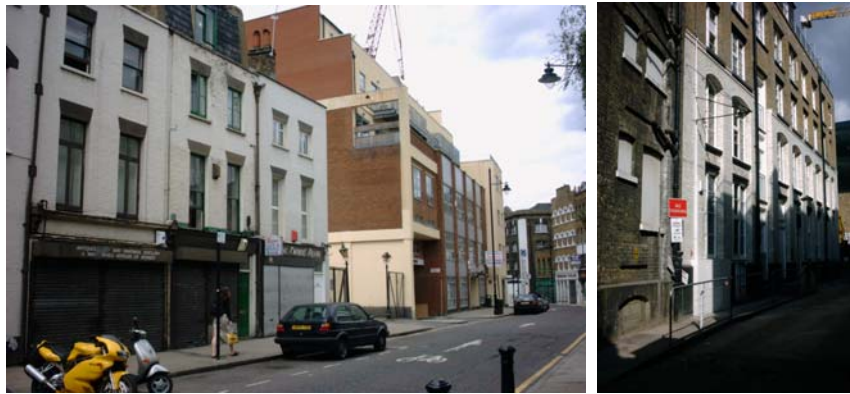
Figure 26 (left) New development at 194 to 204 Bermondsey Street dominates its historic neighbours at 210-214, despite a stepped front elevation.

Figure 27 (right) Some industrial buildings in yards behind Bermondsey Street are large scale (Newham's Row).

- 3.2.13. Southern Bermondsey Street is experiencing significant pressure for renovation and redevelopment. This is most noticeable at the edge of the Conservation Area in sites and yards behind the main building frontages, e.g. in Newham's Row and behind 156 to 170 Bermondsey Street. Some existing industrial buildings in these locations are large (see Figure 27), but it is important that these are not taken as precedence for over-development for other uses. Many parts of the main street frontage are only three storeys, and in this context, examples such as the new block at 194-204 Bermondsey Street whose flank elevation dominates the buildings around it.

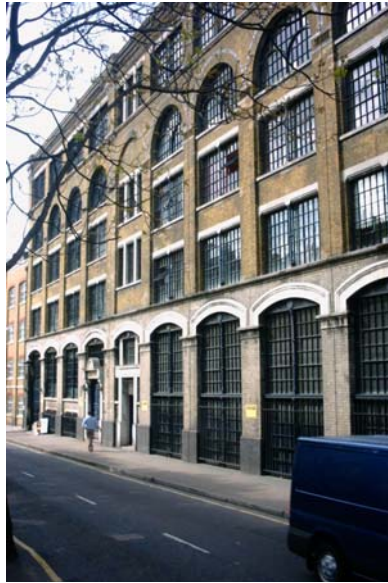
- 3.2.14. In Long Lane, the Conservation Area includes buildings on the north side only. The most prominent is at No. 239, built around 1900 as a fur processing works. At 5½ storeys and 42 metres in length its highly fenestrated and ordered façade dominates the street, counterbalanced by the open space of the playground opposite (site of the 18th/19th century Quaker Burial Ground, but outside the Conservation Area). The mature trees lining the southern side of the street are important to the setting of the buildings and enhance their appearance overall. The

Figure 28 Long Lane: No. 239, the imposing façade of this former fur processing works is very influential on the urban quality of the street.

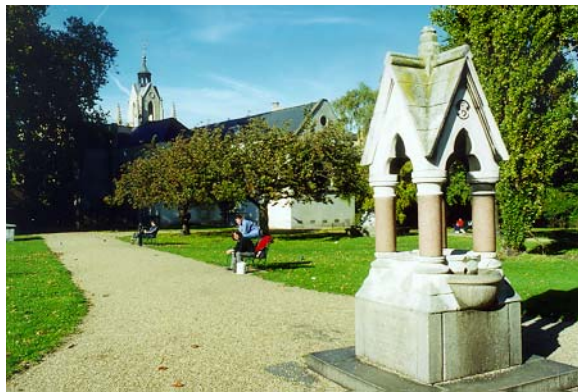
- 3.2.18. The low steeple of St. Mary Magdalene Church is one of the most important landmarks in the Conservation Area, situated in a key position on the only bend in Bermondsey Street and visible between building frontages along most of the length of the street. Past the Church, the narrow street opens out again as far as the corner with Long Lane, and the churchyard provides a green counterbalance to the simple, strong building line on the western side. Looking back into Bermondsey Street, the church again has importance, positioned at the focus of views on the outside curve of the street. It is also important as a landmark in a number of viewpoints from Tower Bridge Road and the south-east across the churchyard and Bermondsey Square. It is important that the relatively low scale of development in the vicinity of the church, discussed at 0 above, is observed to preserve the setting and views of the church.

Figure 29 Views to St. Mary Magdalene are of great importance in the Conservation Area: any higher development in the vicinity of the church would compromise the skyline view of the steeple.

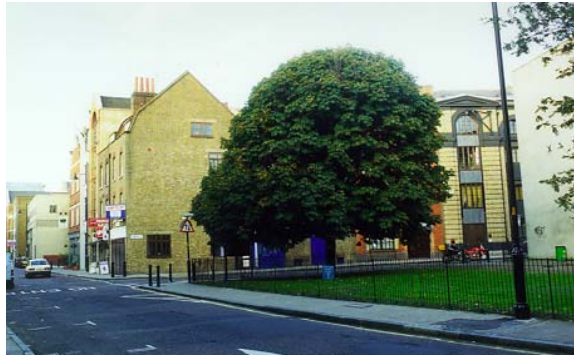
- 3.2.21. At the centre of Bermondsey Street there is now a significant small space where corner buildings to Tanner Street have been lost and converted to a landscaped sitting area. In the narrow street it provides a significant contrast of spatial quality, and gives an open outlook to shops on the western side. It is contained by the gable ends of 1 Tanner Street and 109 Bermondsey Street. A large horse-chestnut tree approximately on the original building line provides visual focus and ensures that the linear character of the street is partially maintained. The space is at the middle

Figure 30 Junction of Bermondsey Street and Tanner Street: a small pocket of green that provides a useful sitting area for people living and working nearby.

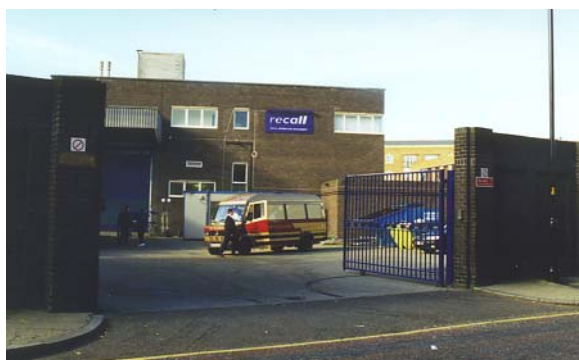
- 3.2.23. A works yard south of Lamb Walk creates a serious gap in the street frontage. Its dark brick yard wall is visually intrusive and a wide vehicle access exposes a large concrete yard and a modern warehouse behind.

Figure 31 Intrusive warehouse development, Bermondsey Street: the yard breaks the continuity of the street frontage, the boundary walls remove vitality and interactiveness from the scene, and the building itself is not part of the street.

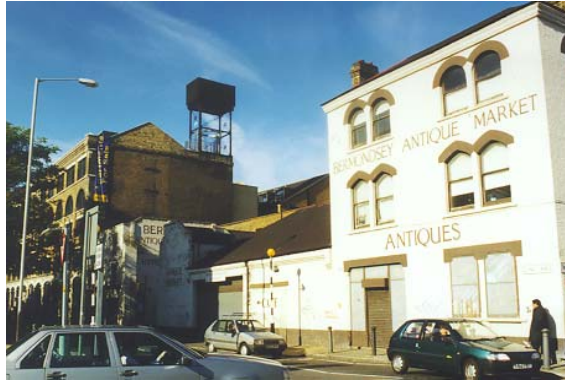
- 3.2.25. There is a group of poor quality single-storey buildings between 247 and 253 Long Lane. The site links to a gap between 204 and 210 Bermondsey Street. The frontage of the site onto Long Lane includes 19th century houses at 241-245 which, although in poor condition, retain original features internally.

Figure 32 Long Lane: the corner buildings are important in the townscape (see 0 above) but there are gaps between them and three houses at nos. 241-245.

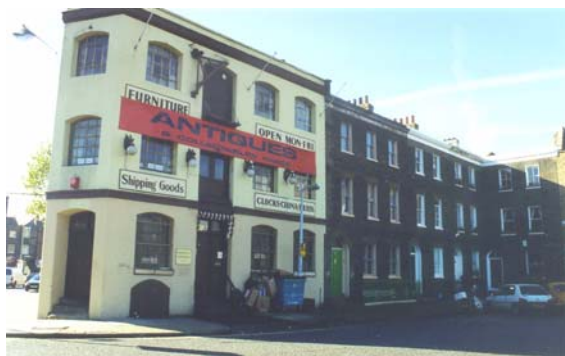
- 3.3.1. The characteristics of Bermondsey Square are its openness and the fragmented nature of its street surfaces. Of the original urban form, only the south west corner of the square remains, at nos. 2-5. These four early 19th century houses indicate how the corner of the square was neatly turned, carrying through the simple detail and proportion of the brick façade. The group retains iron railings to the front areas, which are important in illustrating the street character of the original square before it was lost by the construction of Tower Bridge Road and later 20th century damage and redevelopment. The small oval garden at roughly the centre of the original square is a token of its former urban character, and the enclosing railings and neatly clipped privet hedge are part of this earlier setting.

Figure 33 South side of Bermondsey Square: the houses are all that remain of the original square, and the warehouse was added to finish the block neatly when Tower Bridge Road was broken through.

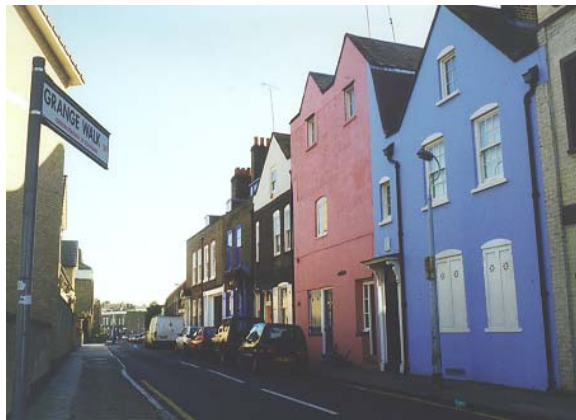
- 3.3.3. Grange Walk is a narrow, historic street, whose character is created primarily by the buildings on its south side. Elements of the listed building group at nos. 5 to 11 date back to original abbey structures; this was the site of the mediaeval gateway. The whole group dates from the mid-17th century. The building forms reflect these origins, with varied elevational proportions and window patterns, gables facing the street and rendered painted façades. The buildings stand well forward in the street, narrowing it to only eight metres or so, and creating a pinch point that separates Grange Walk from the noise and traffic of Tower Bridge Road.

Figure 34 17th century houses on the site of the abbey gateway: their gabled forms are on contrast to the more formal elevations of later development.

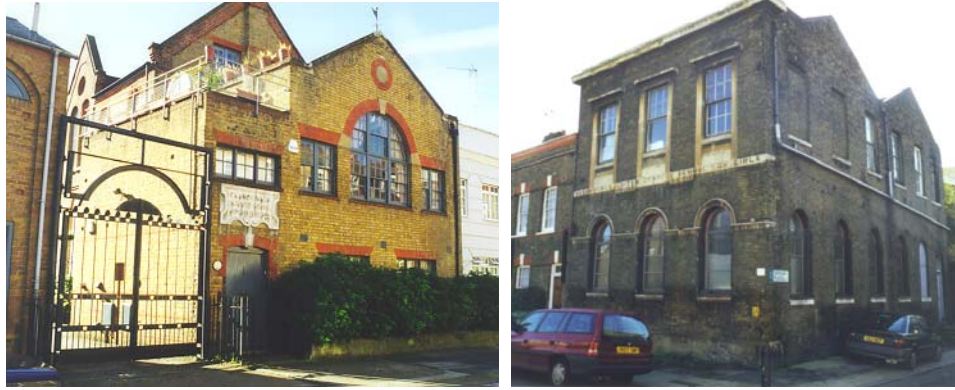
- 3.3.4. The remainder of the street within the Conservation Area is characterised by neat and regular 19th century brick terraces, with key buildings marking street corners at the ends. The former Bermondsey United Charity School for Girls stands on the corner of Griggs Place, framing the western end of the terrace. At the eastern end Grange Walk Mews, also a former school, has a similar role. In between, the terrace at nos. 16 to 30 is well preserved with few inappropriate changes and almost all of its original simple brick detailing. The continuous lines of the second-storey roof parapet and, at ground level, of boundary fences and walls to short front gardens create an uninterrupted containment of the street space.

Figure 35 (left) Grange Walk Mews, converted from a former school, and

Figure 36 (right) the former Bermondsey United Charity School for Girls

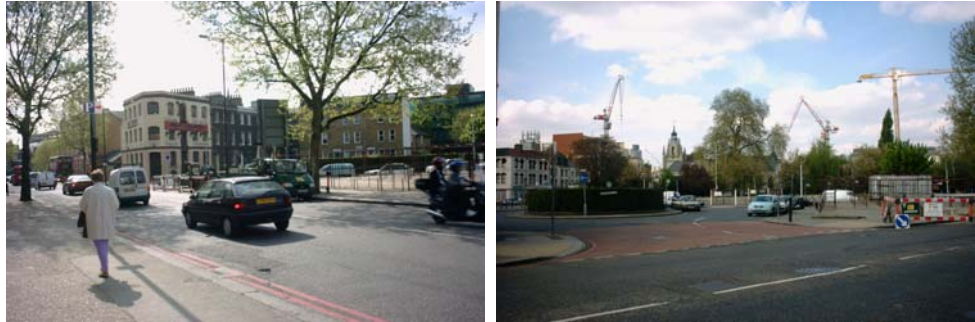
- 3.3.7. In Bermondsey Square, the buildings provide a visual and historic reference point, but the confusion of parking areas, fences, hoardings and market storage undermine the identity of the space. The remaining oval garden in the former centre of the square is also an important historic reference, but it appears isolated from its original context by the changes in the street scene that have occurred around it. In particular, Bermondsey Square lacks clear differentiation from Tower Bridge Road and the traffic intrusion associated with it.

- 3.3.8. The openness of the space in the present day nevertheless allows views from Tower Bridge Road to the landmark of St. Mary Magdalene's Church. The eastern side of the square is formed by the southern end of Bermondsey Street, and this affords an excellent vista northwards along the street to the front of the church, positioned as the street bends to close the view. 255 Long Lane is prominent on the corner of Bermondsey Street, marking the north-west corner of the square. Southwards, there are views out of the Conservation Area to the Tower Bridge Road primary shopping area, establishing a link between it and the market.

Figure 37 (left) Bermondsey Square looking south-west: the space is dominated by Tower Bridge Road, and

Figure 38 (right) looking north-west: although the result of demolition, there are now good visual links back to St. Mary Magdalene church.
