<b>Item No.</b>	<b>Classification:</b> Open	<b>Date:</b> 29 October 2019	<b>Meeting Name:</b> Cabinet
<b>Report title:</b>		Ledbury Towers Arup Structural Survey Report	
<b>Ward(s) or groups affected:</b>		Old Kent Road	
<b>Cabinet Member:</b>		Councillor Kieron Williams, Housing Management and Modernisation

Before proceeding with this refurbishment the council engaged the structural engineers Arup to carry out intrusive investigations into the structure of Bromyard House to confirm the work needed to give the towers a further 50 plus years of life.

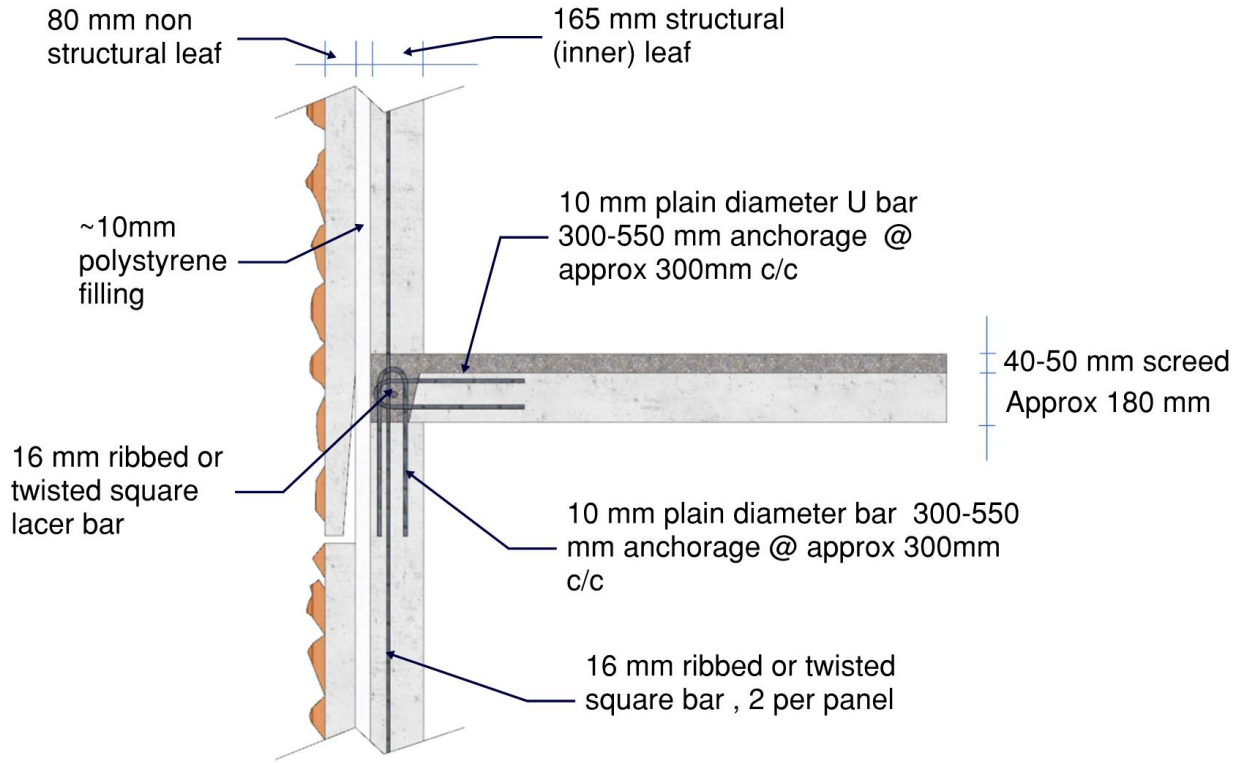
#### Flank wall/floor/flank wall connection

The connections in Large Panel Systems are known to be vulnerable to the quality of the site workmanship. Evidence of poor site workmanship was found during the investigations with sand instead of grout found in one of the wall to wall connections.

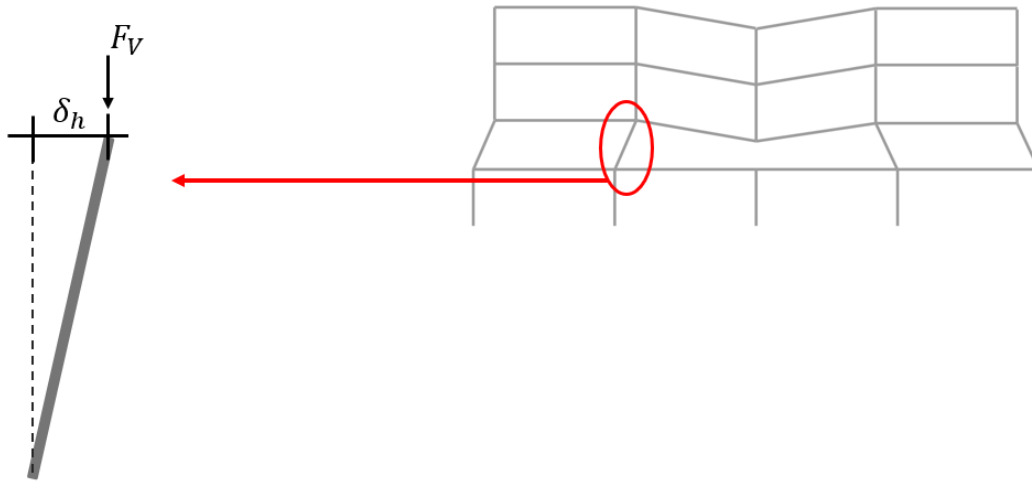
In addition, tying action following the loss of one wall would pull in the adjacent walls as shown below. This would put large additional (“P-delta”) forces into the walls, which again the walls at Ledbury would not be able to accommodate.

Further, the loss of one wall (in the manner shown above) would shed more load onto the adjacent walls. These loads would be further amplified due to the dynamic nature of a sudden wall loss due to an accidental event such as a gas explosion. The connections and elements at Ledbury Estate would not be able to accommodate these large forces.

For the reasons discussed above, tying would not in practice improve the resistance of Ledbury Estate against disproportionate collapse, and therefore it is not recommended to strengthen the buildings by this method, even though this would be sufficient to comply with the current Regulations.

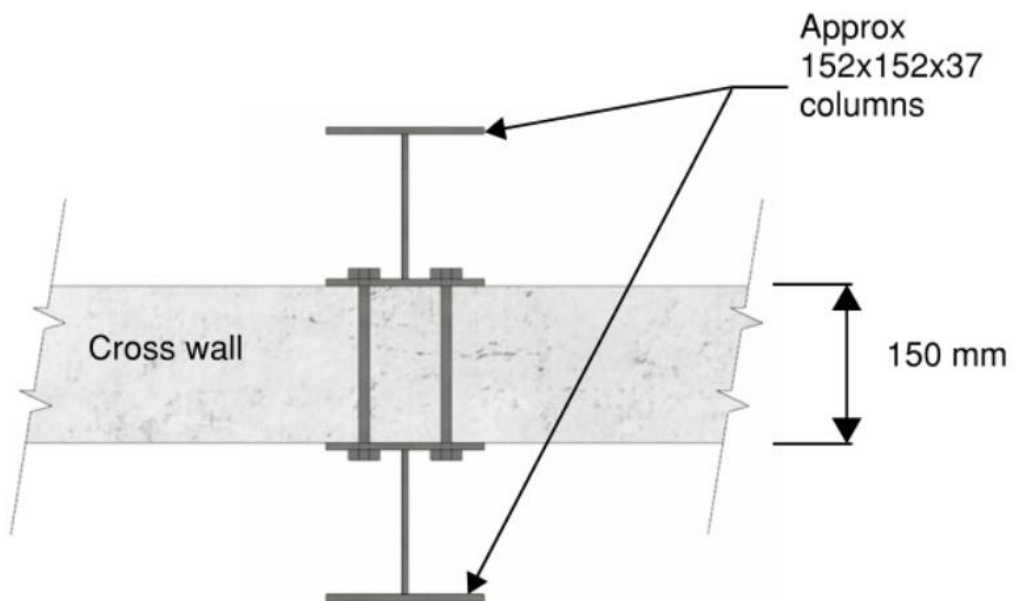
The cross walls separating the 1 and 3 bedroom flats (Floors G to 4) are not able to withstand 17 kPa by arching as they have no load from the floors above. As such it is proposed to install steel columns and beams designed to act as key elements to withstand 17 kPa to create an alternate load paths in the event of loss of this cross wall (see image below).

7. Cross walls separating 1 and 3 bedroom flats (Floors G to 4) – Add steel columns.

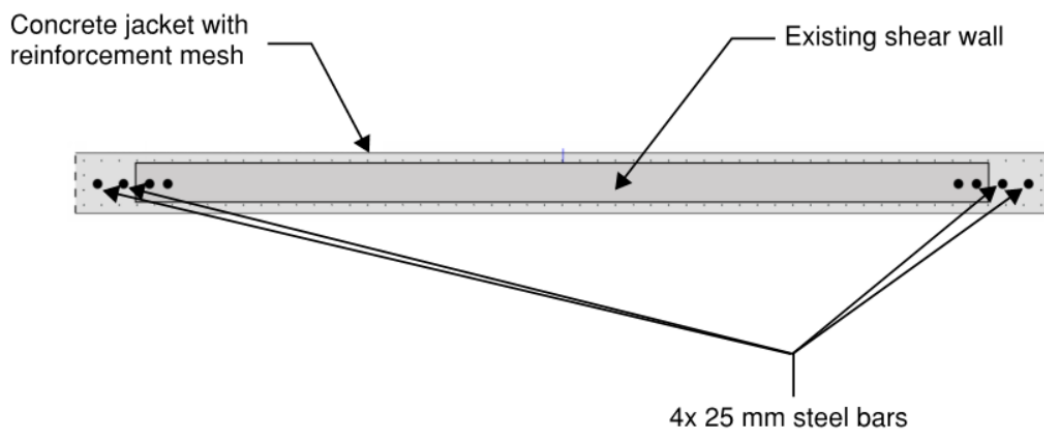
Since the anchorage of the shear wall reinforcement into the foundation is unknown (and likely to be deficient since the wind loads the building was designed for are known to have been too low) and the workmanship of the connections in the shear wall at every joint at floor level is unknown (but known to be vulnerable to poor site workmanship; sand was found in one of the wall to wall connections), it is proposed to include enough steel reinforcement for modern wind loading within the new jacketing.

- 9. Shear wall - Add jacketing.

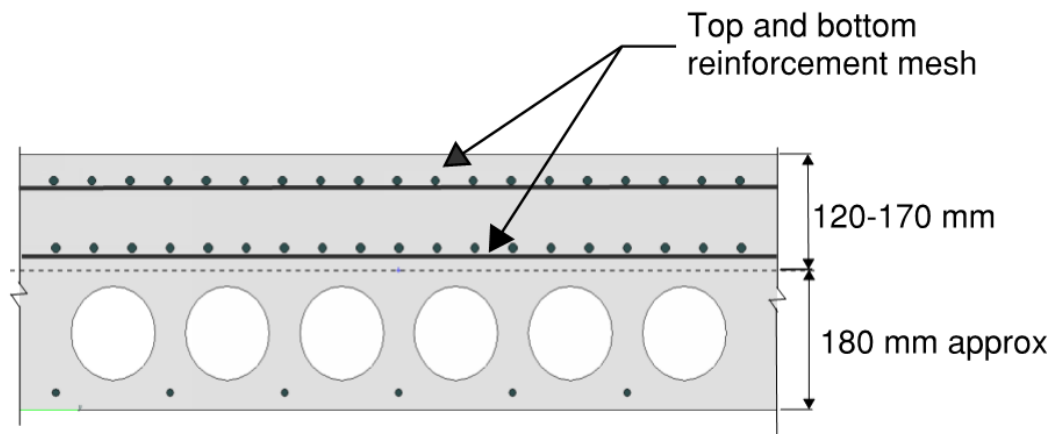
It was also found that the hollowcore floor panels do not fully comply with the gravity loading requirements in the current UK concrete code.

10. All floors – The screed should be removed and a new thicker reinforced screed should be cast.
